**From:** Lachlan Riehl  
**To:** [Abraham Zebian](#); [Paul Morton](#)  
**Cc:** [PublicOnlyCouncilEmail](#)  
**Subject:** Halfway River - Information Re Flooding and Erosion Risks  
**Date:** November 19, 2024 9:38:48 AM  
**Attachments:** [2021-2022 Halfway River Habitat Assessment Report February 2022.pdf](#)  
[Halfway River Habaitat Assessment Report November 2018.pdf](#)

# Halfway River Tidal Wetland Habitat Assessment 2021

*Prepared by:*  
CBWES Inc.

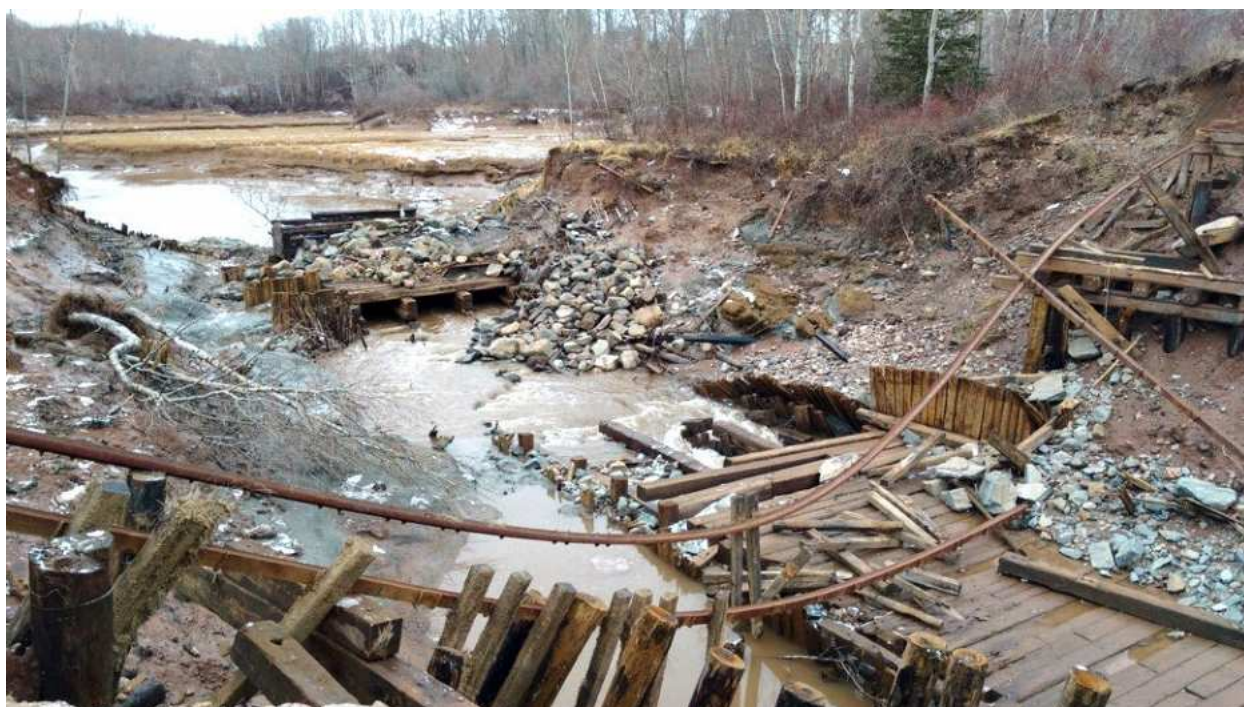
*Figure 3: Mouth of HWR post-failure with aboiteau, construction material and rail line remaining within the crossing (breach) location. Photograph by CBWES Inc 2018.*

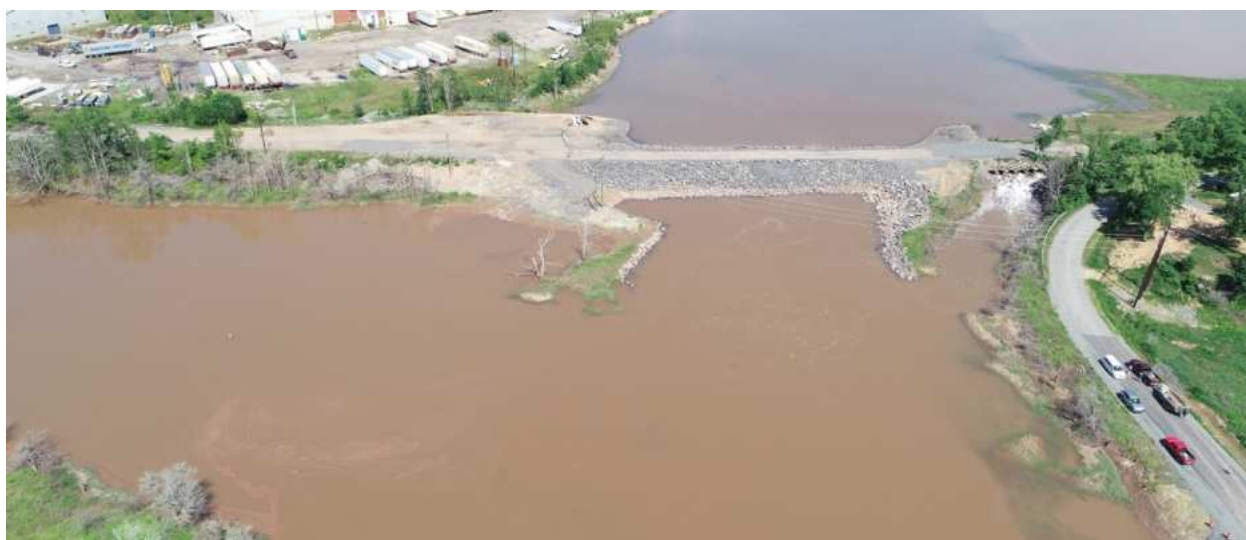
*Figure 5: Causeway at high spring tide (July 7, 2020), tidal ingress occurring through main culvert, evidenced by upwelling, and through the overflow culverts.. Drone Imagery by CBWES 2020.*

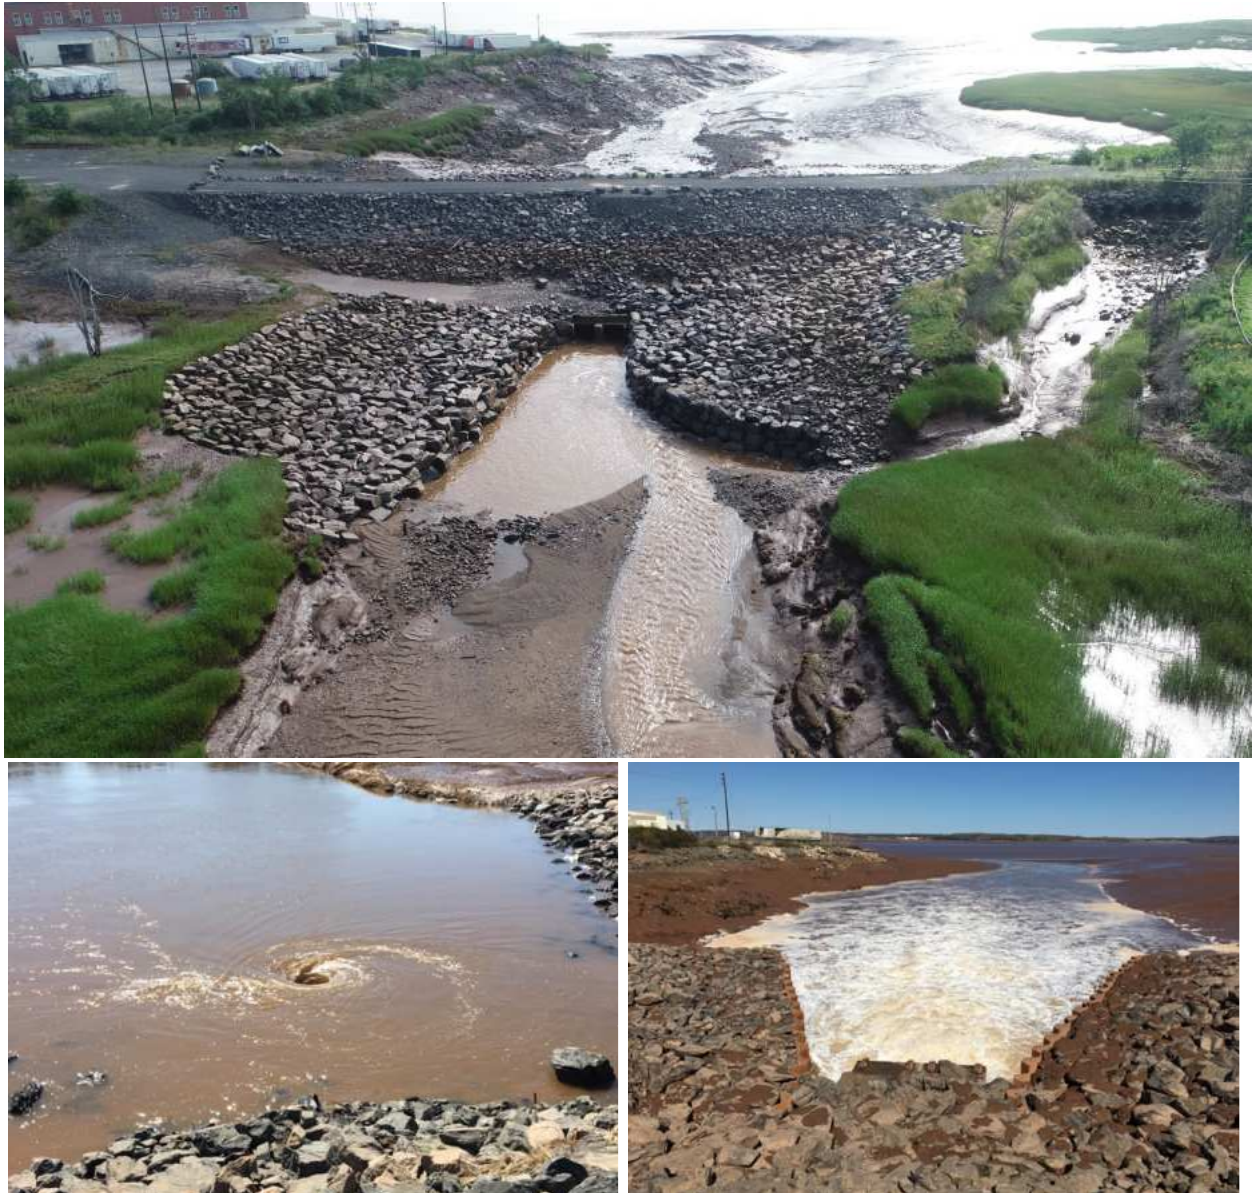
There has been little change in the morphology of the primary channel, except immediately upstream and down of the causeway, where the placement of armour rock and the resulting erosion/scour over the past year has resulted in direct habitat loss and elevation changes. Both velocity and discharge remain similar to the 2019 measurements (made prior to the additional construction activities to re-enforce the structure) with a slight flood dominance.

*Figure 6: The causeway and double box culvert from upstream at low tide August 11, 2021 (Top); Discharge on falling tide downstream of structure with white water conditions for 50+ m (Bottom Right); Eddy upstream on falling tide (Bottom Left) both from May 20, 2020. All photos by CBWES Inc.*

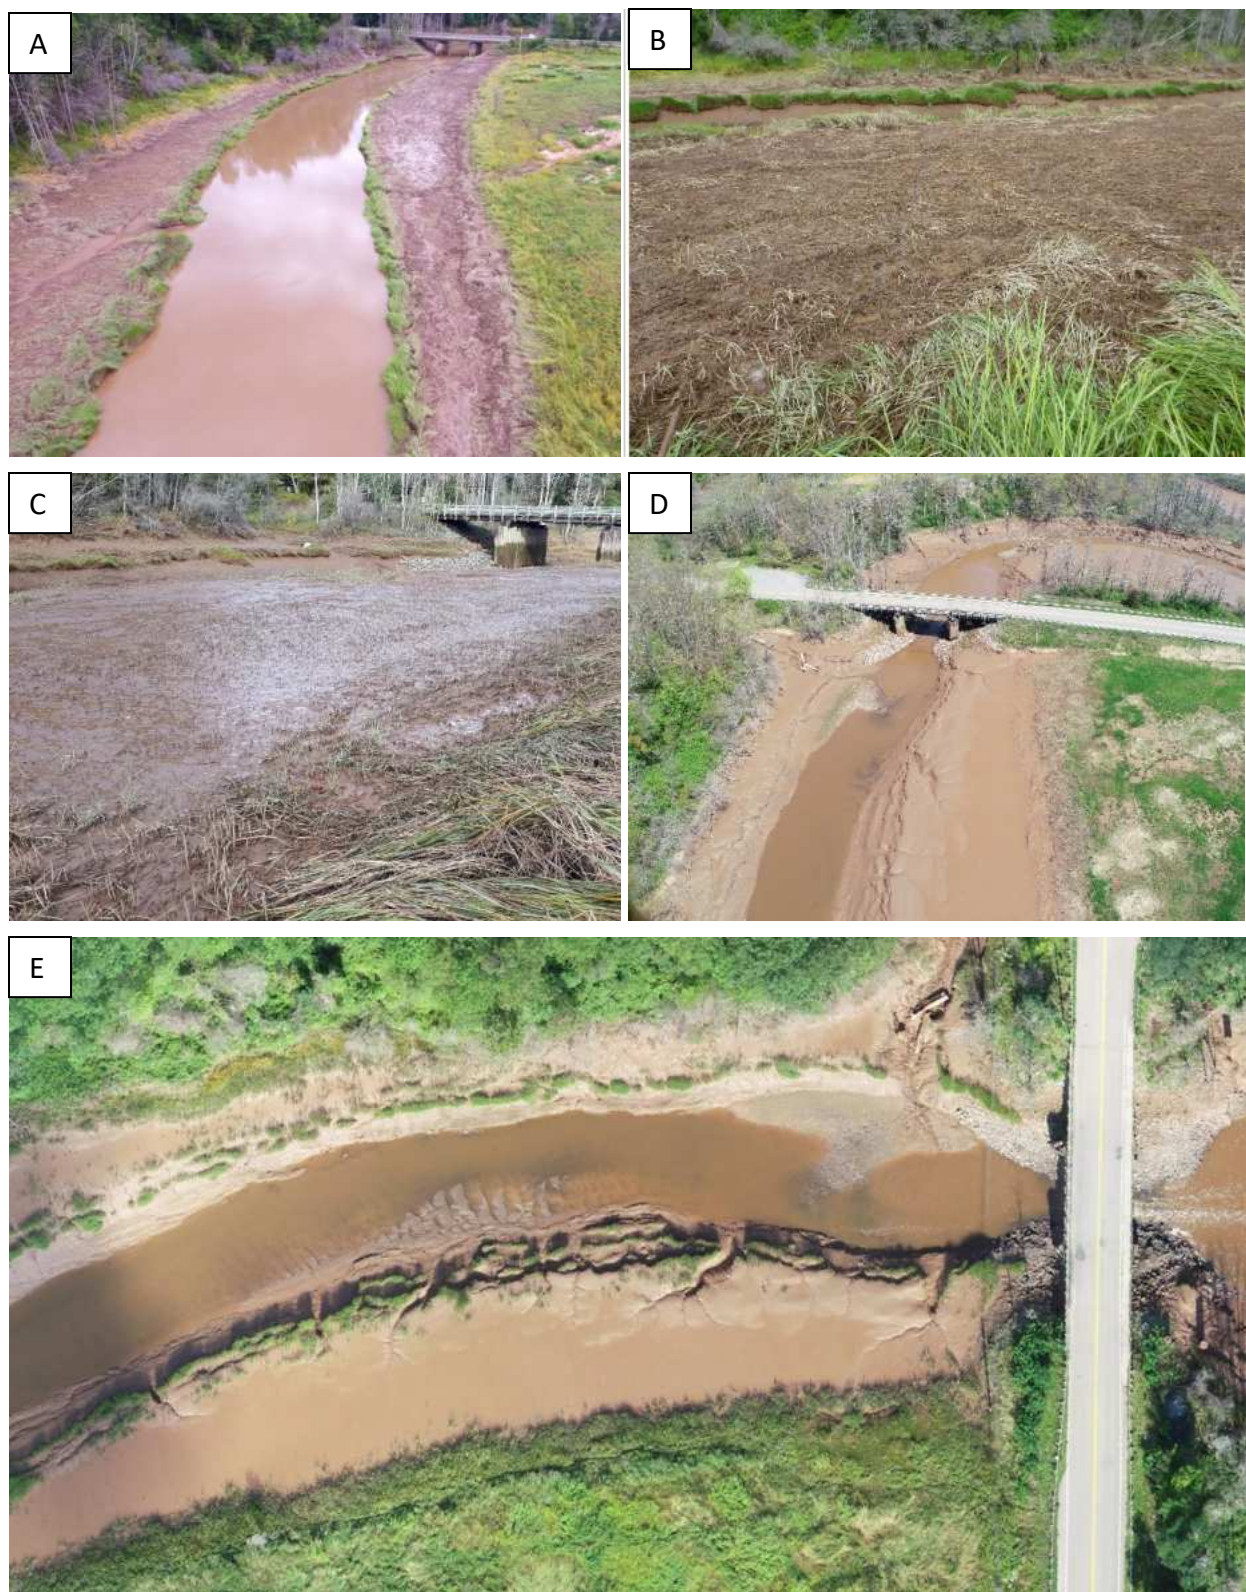
In 2020, an unexplained and sudden vegetation dieback (SVD) of approximately 3.7 ha of *S. alterniflora* was observed, representing 50% of the existing 7.5 ha of vegetated low marsh habitat. Based on the available data and our understanding of the site, it was possible that the change in hydrology and sediment patterns caused by the new structure could have been responsible for poor condition and loss the vegetation. However, there was limited evidence that they alone were the causal agents for the spatial pattern of the dieback. In 2021, *S. alterniflora* coverage totaled 4.7 ha, with 3.8 ha in good condition and 0.9 ha growing sparsely (but not in poor condition). Areas that experienced dieback near the mouth of the system (Transects 1-5) have generally not recovered and remain bare ground. However, areas of low marsh farther from tidal flow (T6+) have retained sparse vegetation in the location of the dieback and have in fact experienced an increase in *S. alterniflora* coverage compared to 2018 levels. The spatial pattern of dieback persisting closer to the river mouth and dissipating with distance upstream, points more towards a contaminants issue. It is likely not a single variable that has resulted in the changes to the low marsh vegetation community observed – but rather the cumulative effects of several stressors. The pattern of dieback, as well as the pattern of recovery, does support contaminants as a primary driver. However, sedimentation and hydroperiod are also considered contributing factors as the change in the environment could also be expected to impact the health of established vegetation, reducing their resilience to other stressors.

Figure 13: Unusual dieback of *S. alterniflora* on the low marsh platform A) August 2020 aerial, B) August 10, 2020, C) Oct 8, 2020, D) May 17, 2021 E) August 11, 2021.

- 2) The nature and source of pollutants entering the system should be identified and eliminated in order to prevent further degradation and loss of habitat and to allow for the recovery of what has already been impacted.

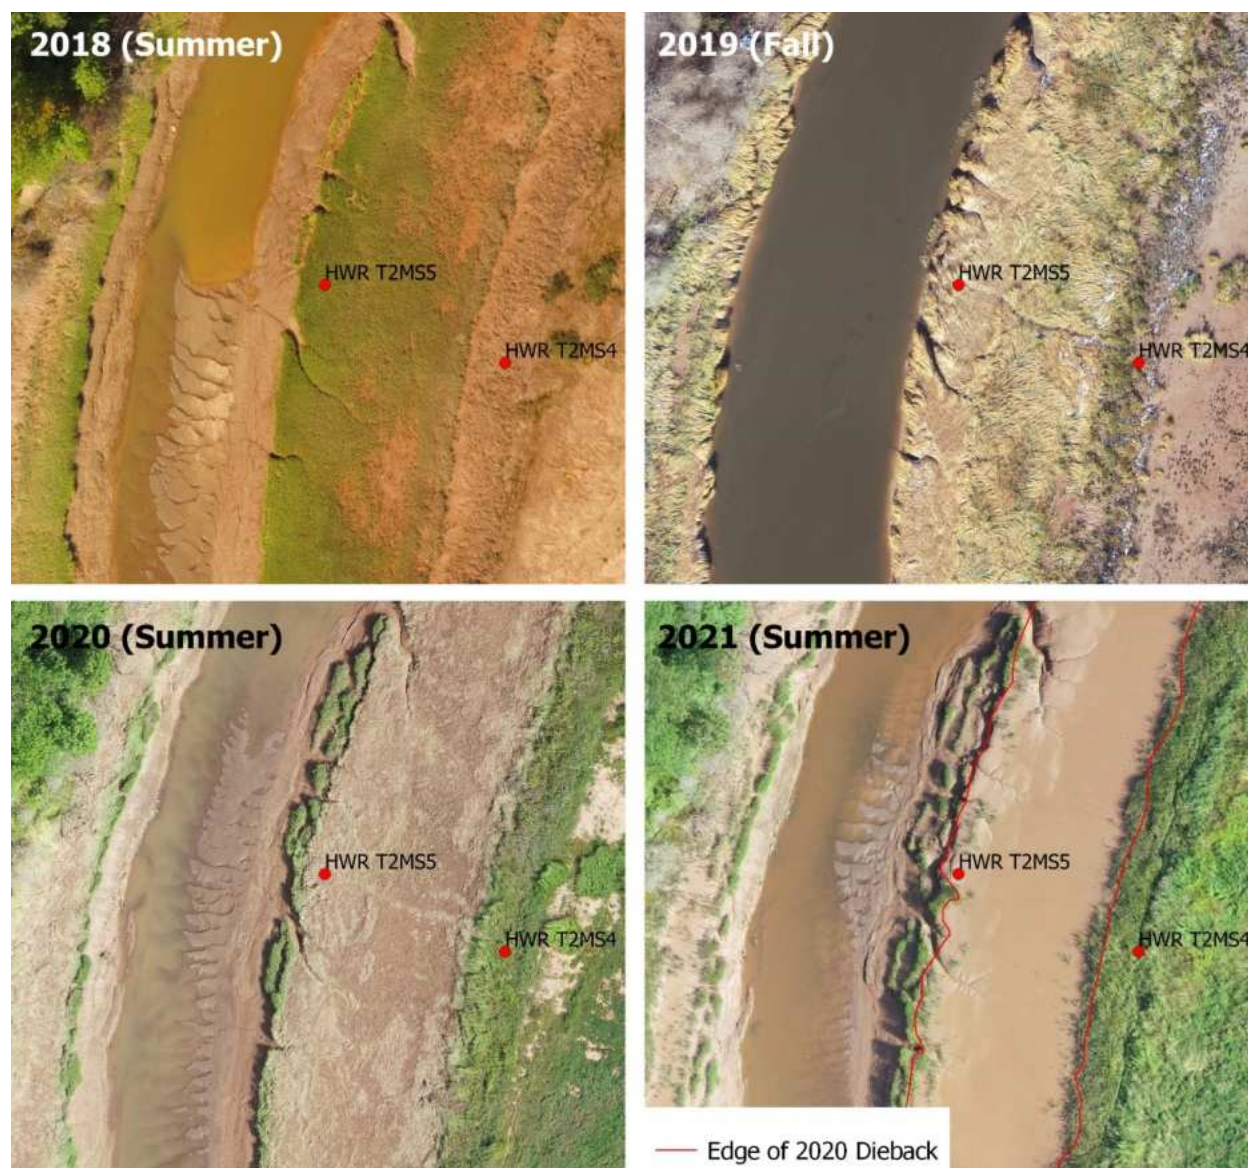
Figure 21: Impact of sudden dieback of low marsh along T1 2018-2021.

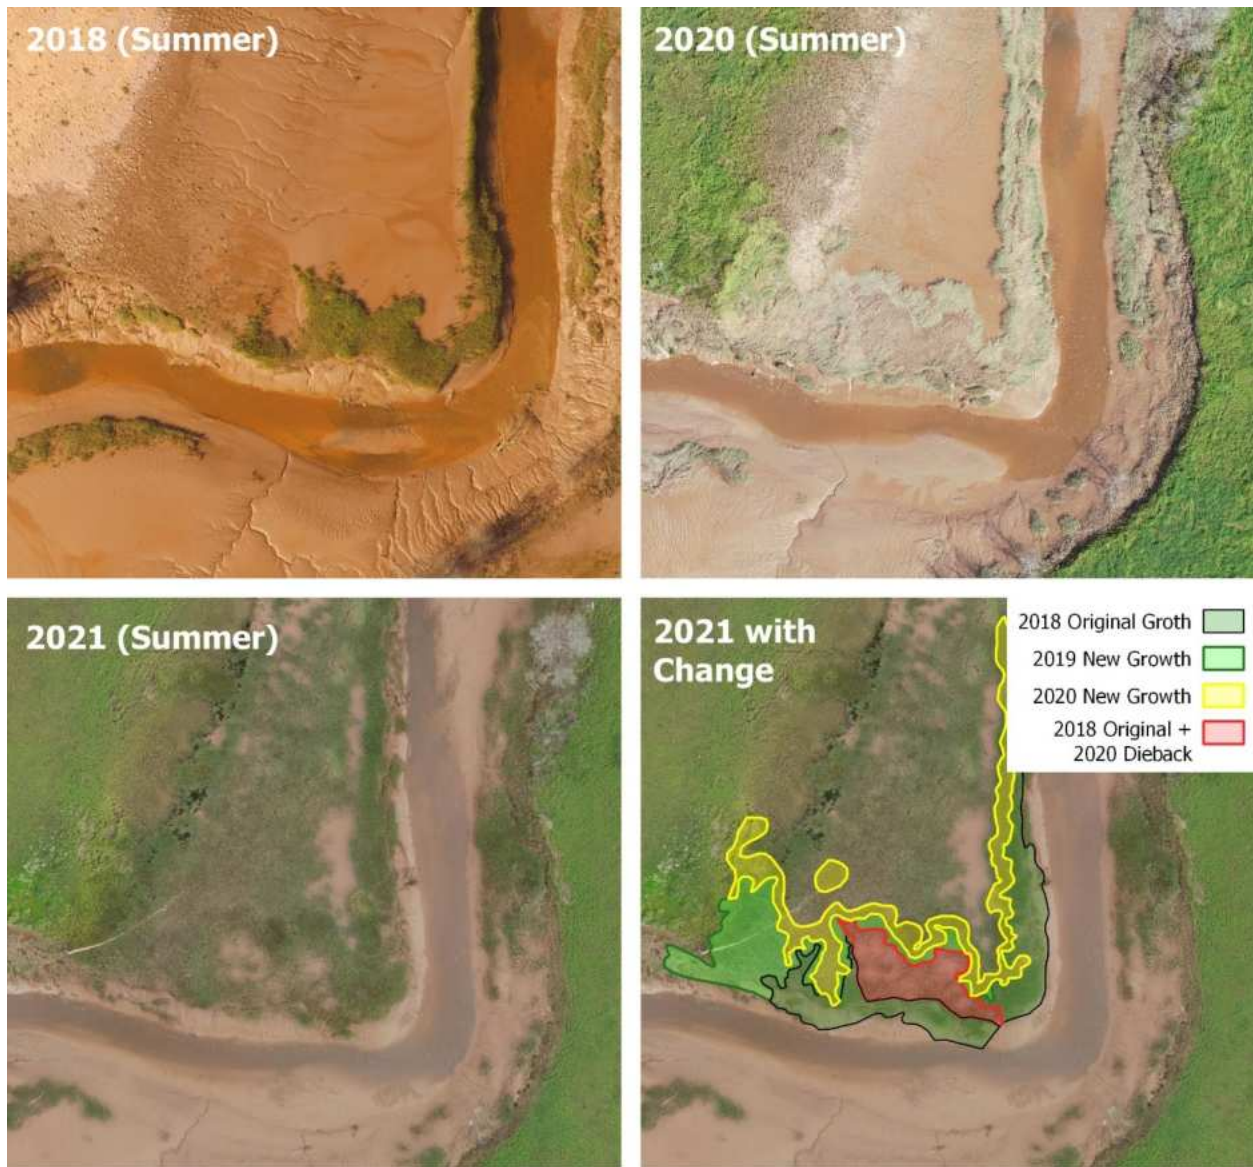
Figure 22: Impact of sudden dieback of low marsh along T6 2018-2021.

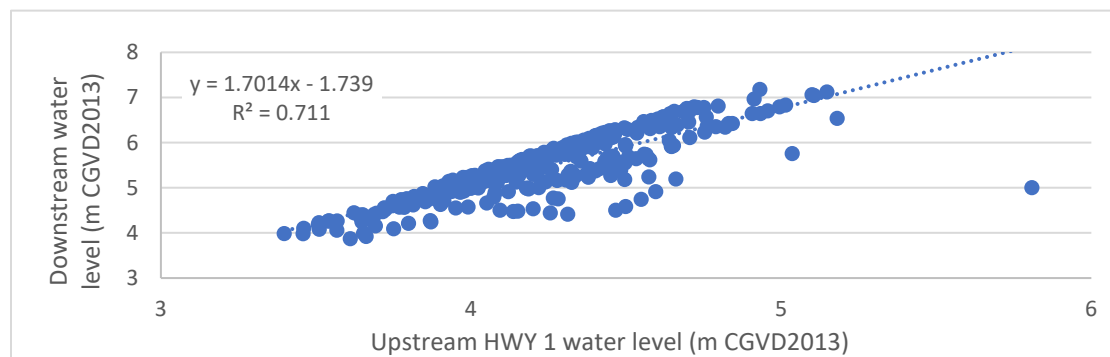
The causeway-culvert has reduced the maximum high tide by ~ 2.3 m from 7.4 to 5.1 m CVGD2013 and reduced flood extent from the 2019 post-breach maximum of 75 ha to 26.5 ha during normal tidal flow. This has resulted in the elimination of tidal flooding of the floodplain (former high marsh platform). Conversely, the hydroperiod and mean inundation time for the low marsh terrace has increased by 15% compared to the 2019 unrestricted conditions. In the fall of 2021 an intense rainfall event (storm) lead to flooding of 80% of the marshland during a neap tide cycle, with water levels inside the site higher than high tide outside the site. A similar, and potentially greater, flood event was observed in February 2022.

Figure 27: Waterlevels at high tide upstream and downstream of the causeway, demonstrating tidal restriction

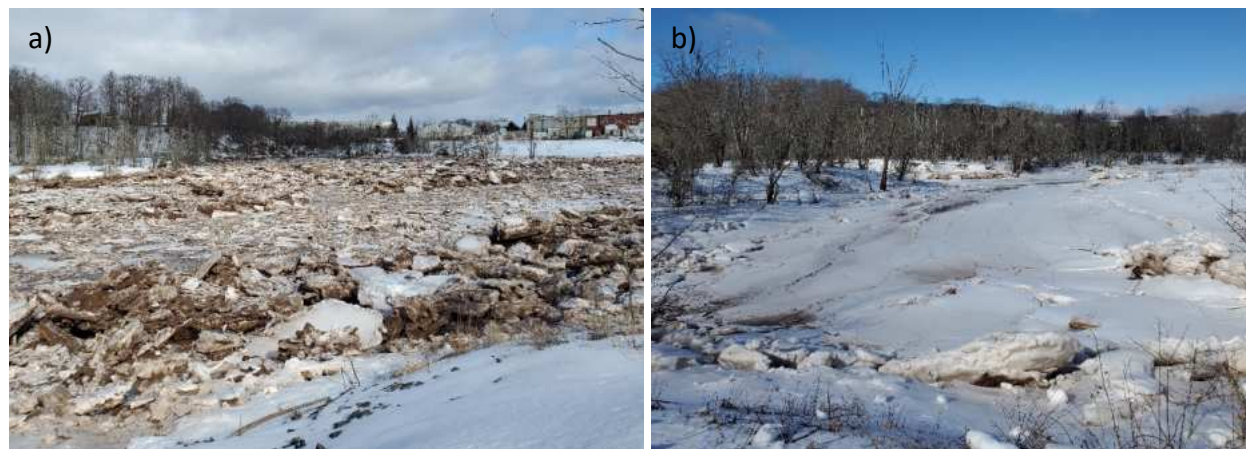
Figure 53: a) Ice blocks located between the causeway and the Hwy 1, and b) ice coverage of the river towards head of tide (just north of the Hwy 101). Photographs were collected on February 9, 2022.

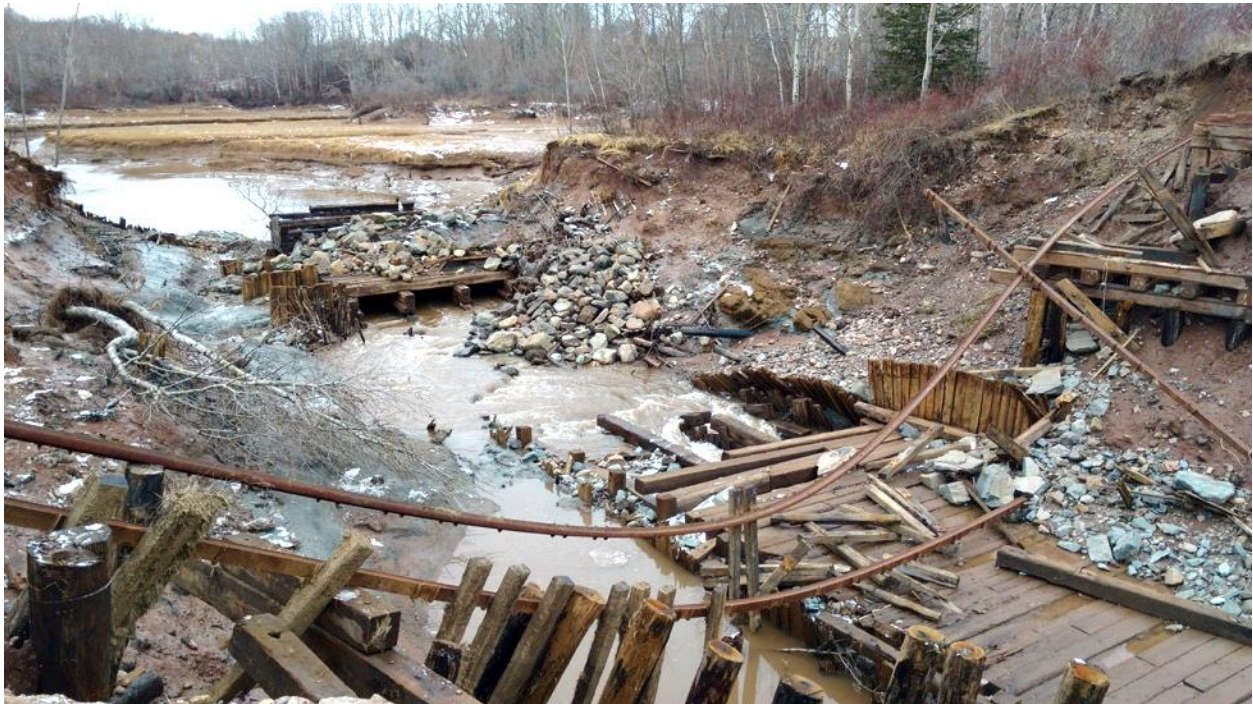
**Figure 3** Part of the aboiteau, construction material and rail line remain within the crossing (breach) location and continue to negatively impact the hydrology. Note – the rail lines visible in this picture from February 2018 have since been removed for safety reasons. Photograph by CBWES Inc.

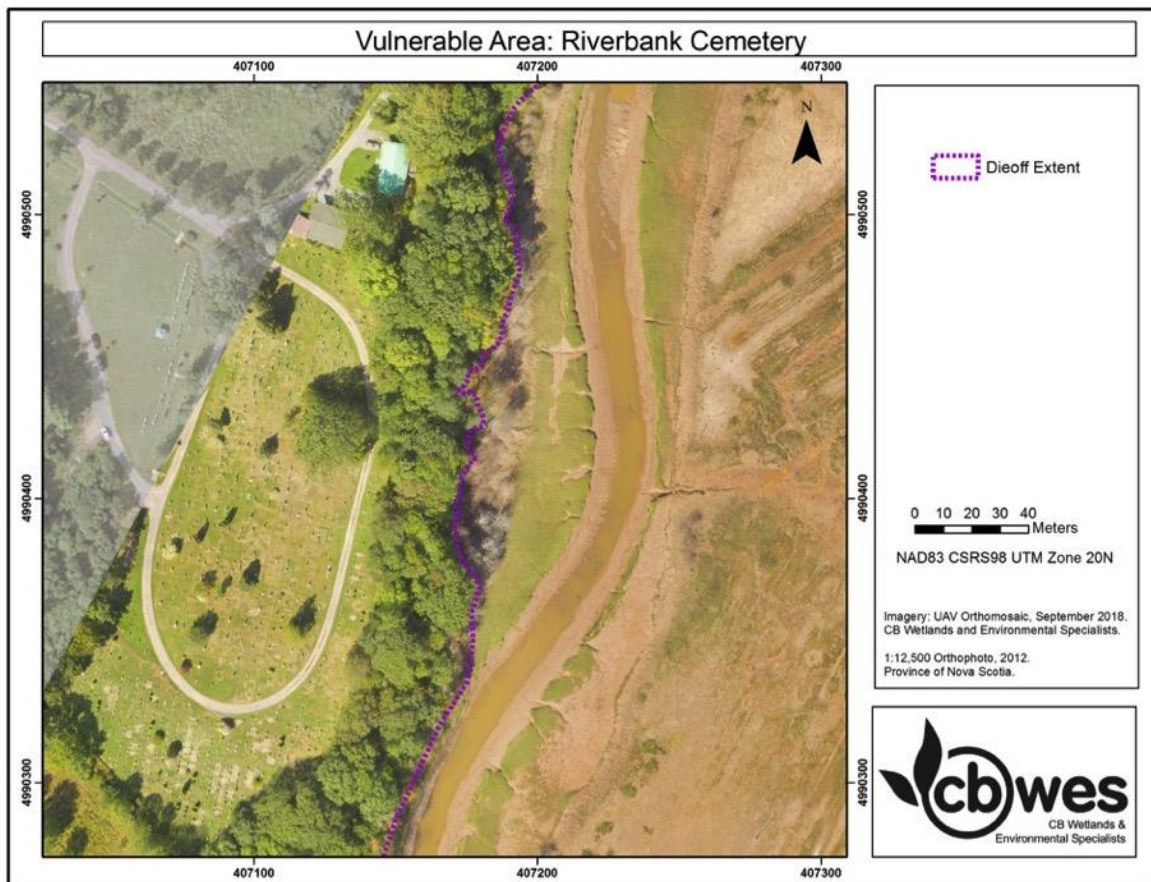
Figure 14 Aerial view of the River Bank Cemetery. The dead trees at the base of the bluff are located primarily on the floodplain directly and not the slope, which appears to be stable at this time.

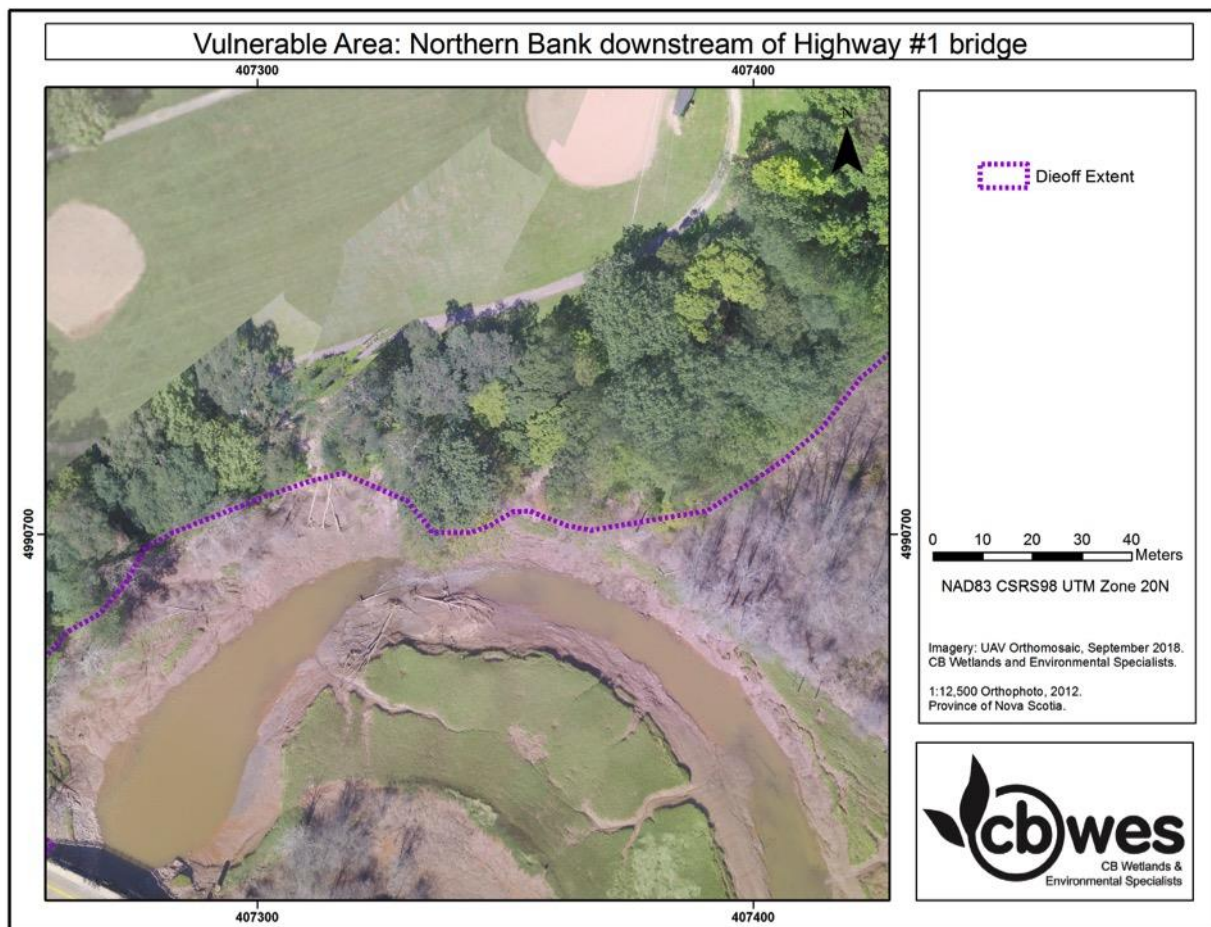
- Erosion concerns from tidal flow were unfounded and observed erosion that was occurring predated the failure of the structure in 2017 meaning it wasn't due to tidal flow.
- A recommended mitigation measure by CBWES to prevent further erosion at this site is to cut down any dead or dying trees in the area before they naturally fall and potentially take a part of the slope with them and further expose and destabilize the bank. This was recommended in 2018 has yet to be actioned by any agency.
- Sections of Highway 1 near the mouth of the river, the Highway 101 Exit 8 on/off ramps, and a low-lying section of Schurman Rd., are vulnerable to flooding during peak spring tides and storm surge events without a tidal barrier in place. However, the report outlined that NSTIR

**Figure 18 Failure of slope near the Hantsport Community Center, which pre-dates the aboiteau failure.**

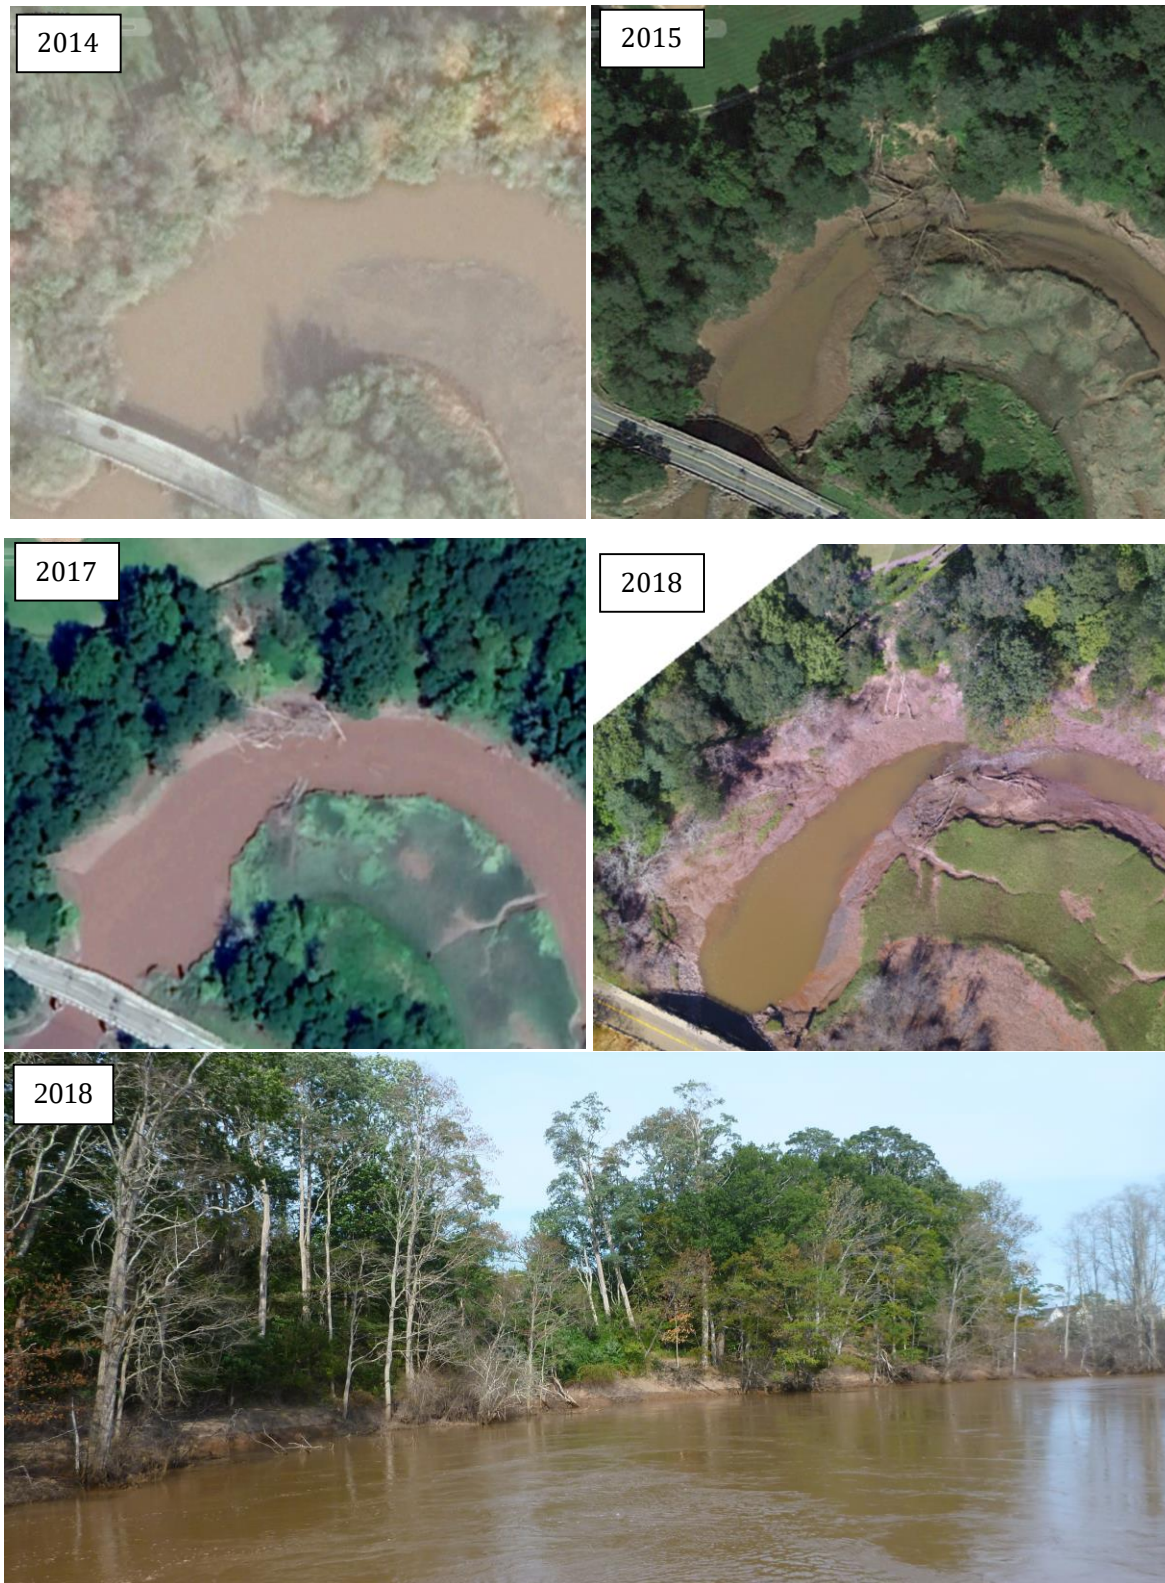
**Figure 19** Progression of slope failure below Hantsport Community Center, 2014-2018 and landscape view at high spring tide, 24 September 2018.

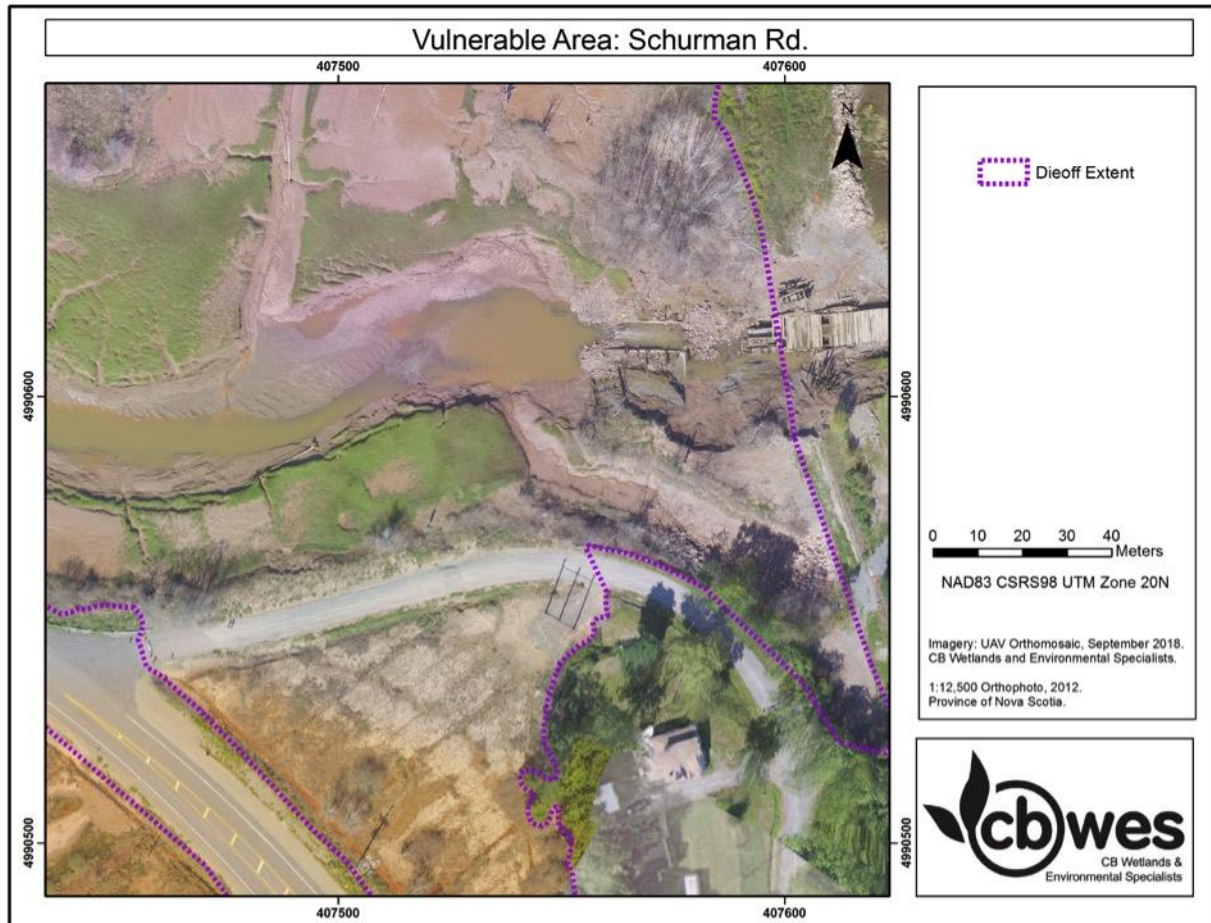
Figure 20 Sediment deposition due to flooding on the low-lying section of Schurman Road (currently closed due to flooding).

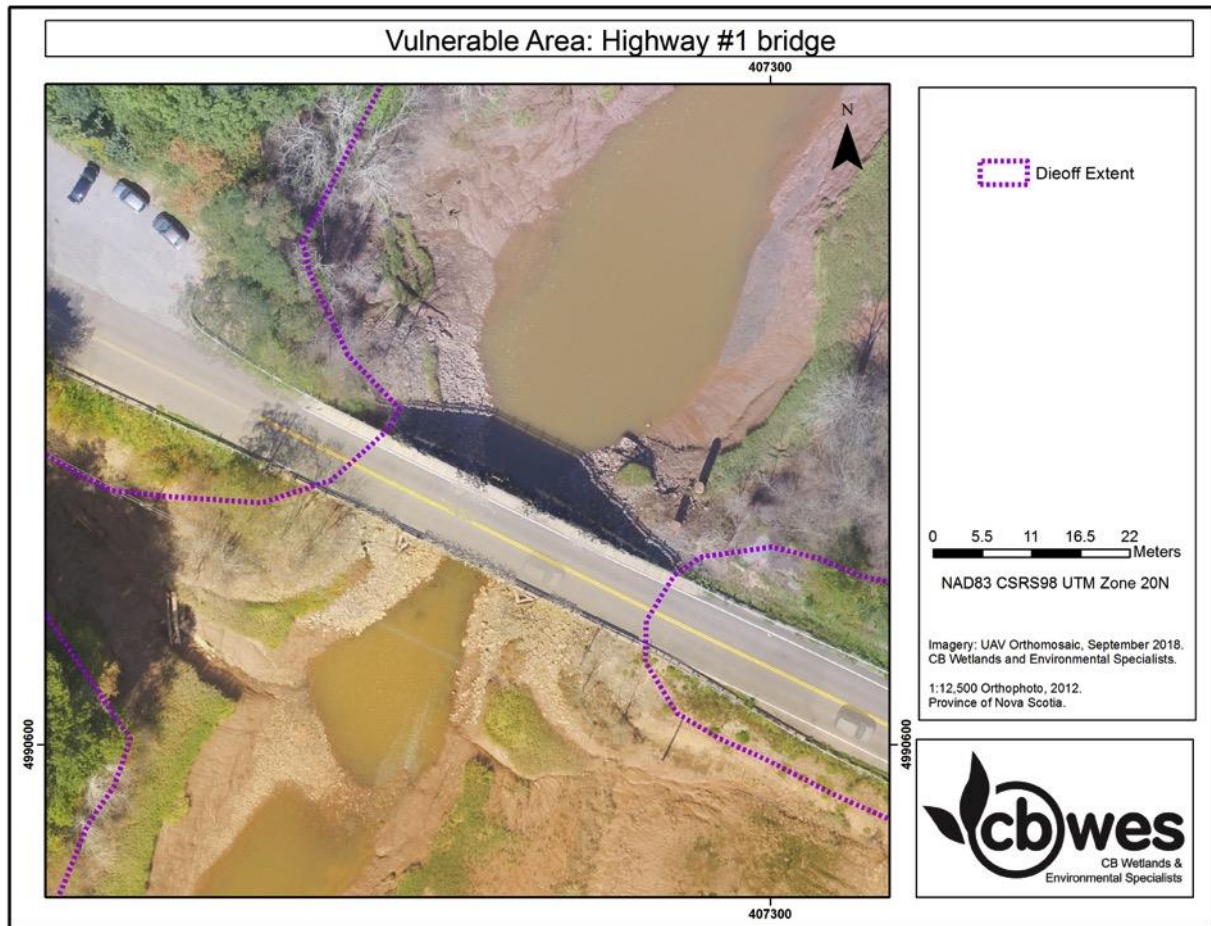
Figure 22 Highway 1 Bridge - scour and eddies observed

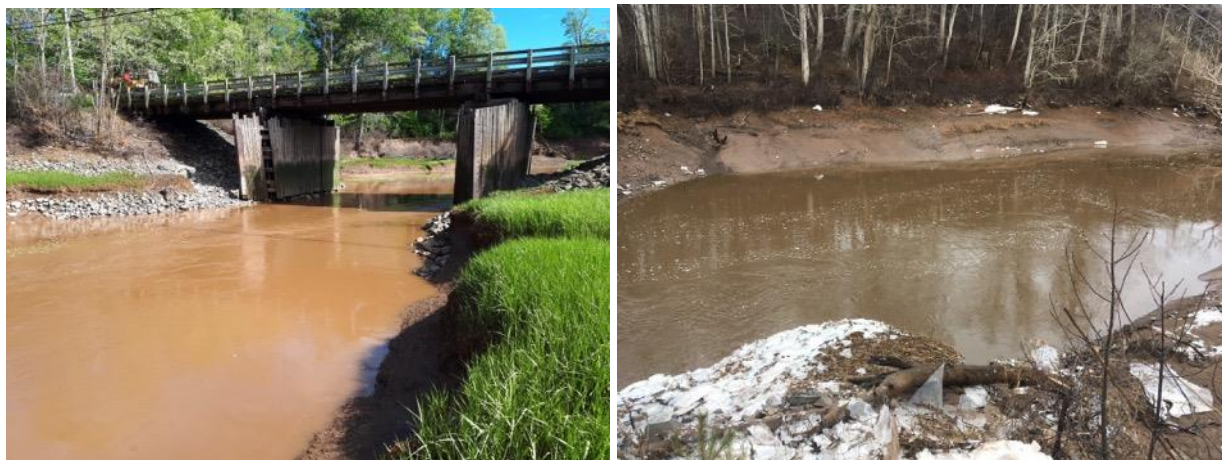
Figure 23 Highway 1 bridge at low tide from upstream marsh (left) and downstream eddies on outgoing tide (right). Photograph by CBWES Inc, 5 September and 7 February 2018.
