# Mill Lakes Observations

Dam

September 23, 2025

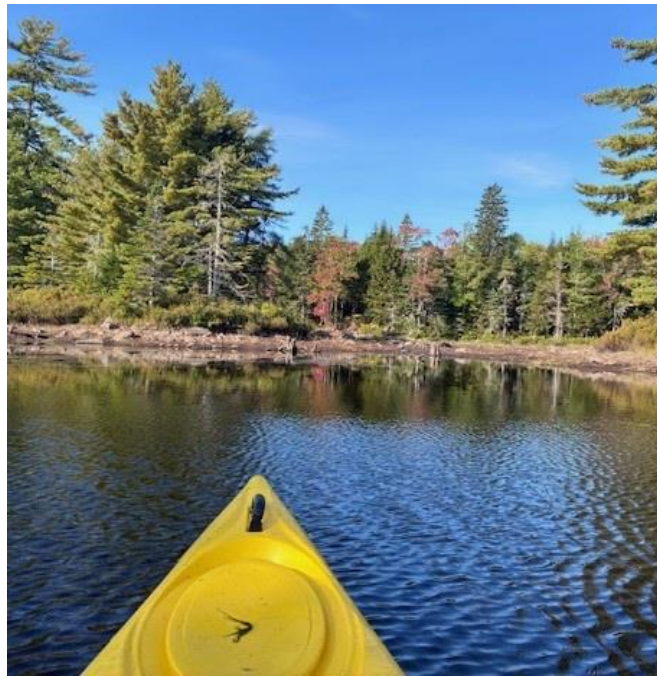
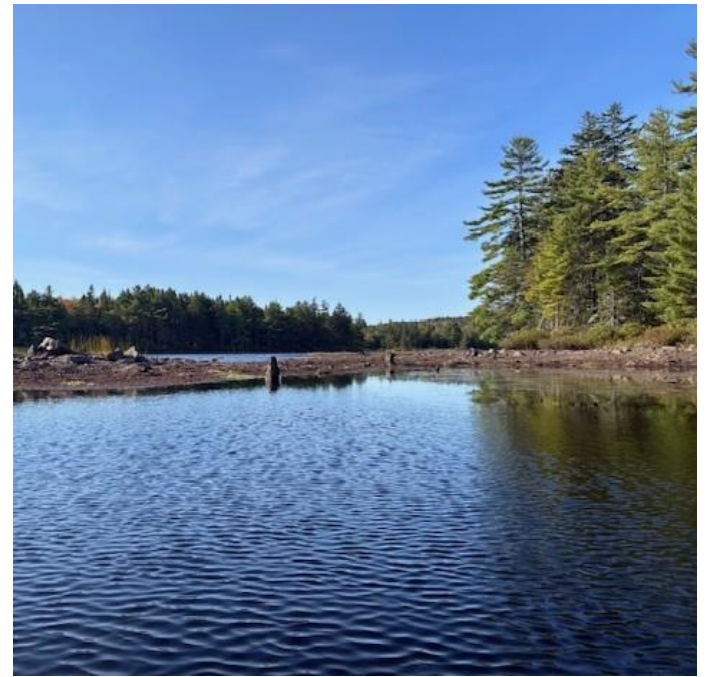
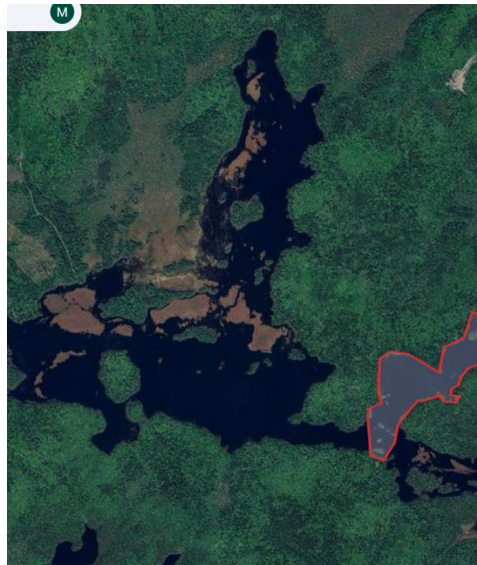
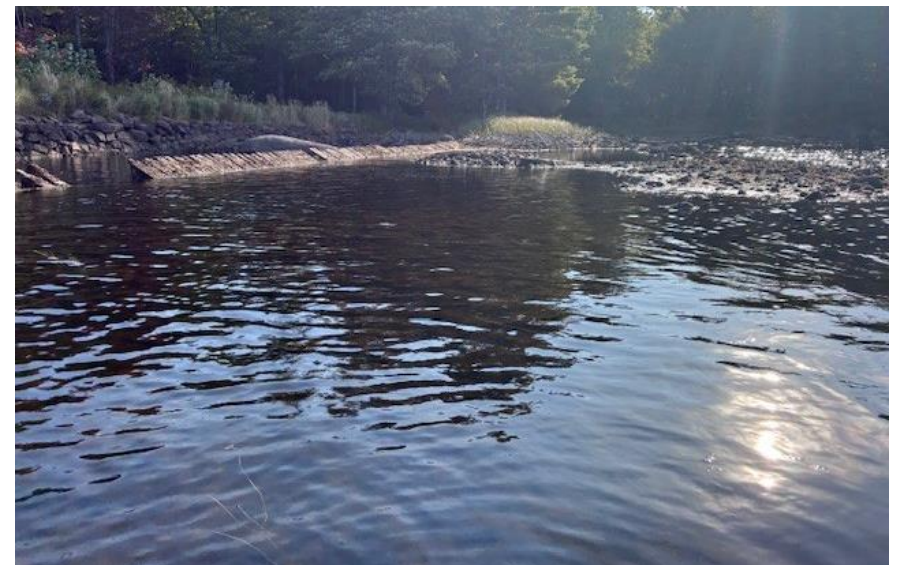
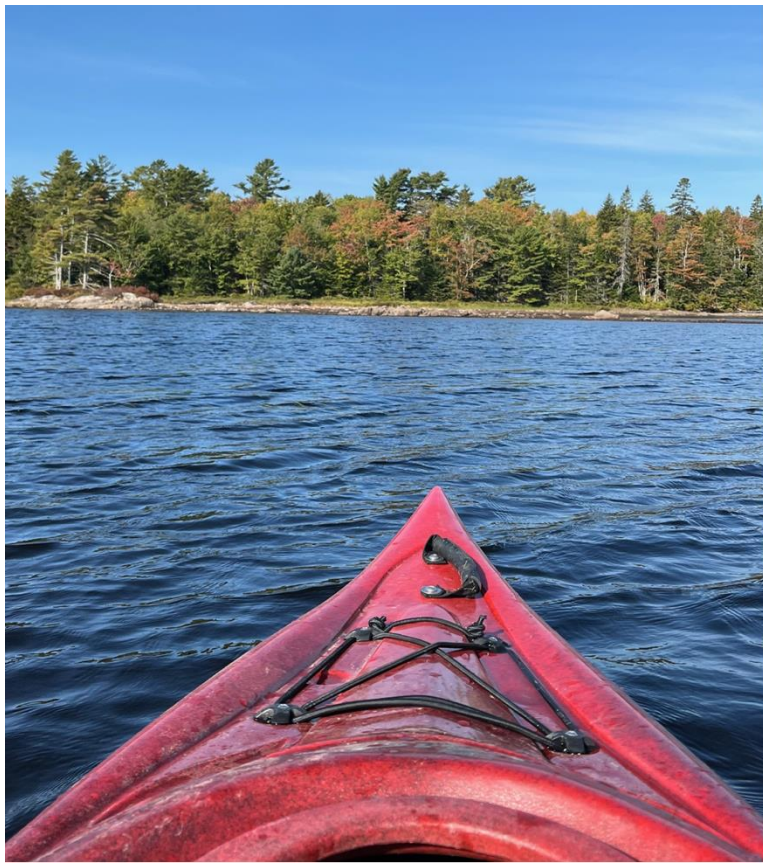
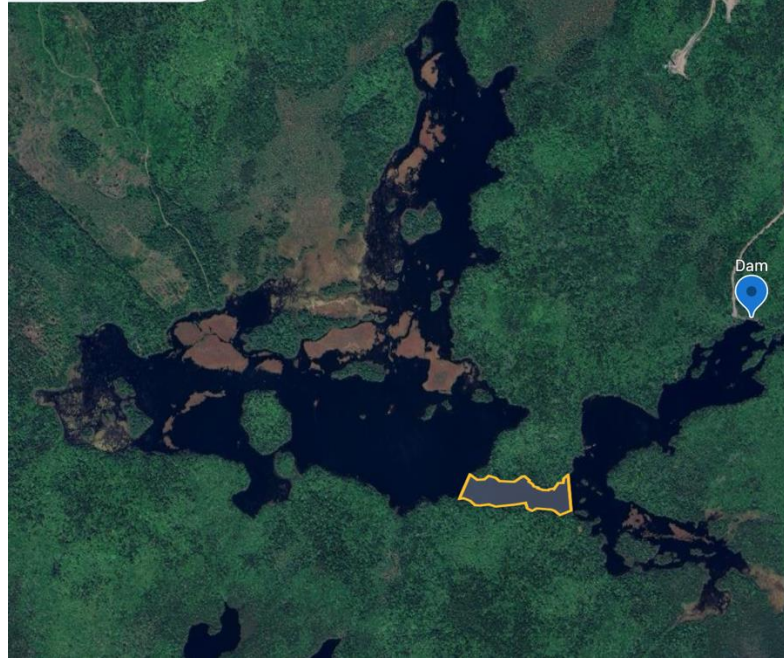
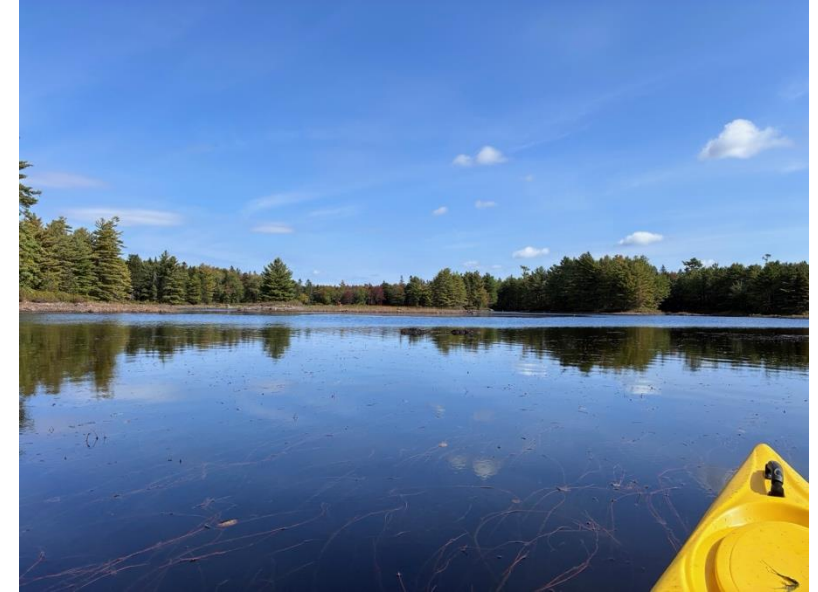
# Dam Area

- Measurements around the dam varied from 36-47 inches
- Further out measurements varied from 45-60 inches

- Dammed area has an average of 47.5 inches based on measurements taken in deeper areas
- Lowest point at the Dam itself measured 47 inches
- The 0 mark on the staff guage (measured in cm) would mean approximately 40 inches (90cm) of water remains in the Dam area of the lake
- Main Lake area has a substantial amount area and volume however due to the change in elevation, a large portion of the lake is not accessible to the Dam area

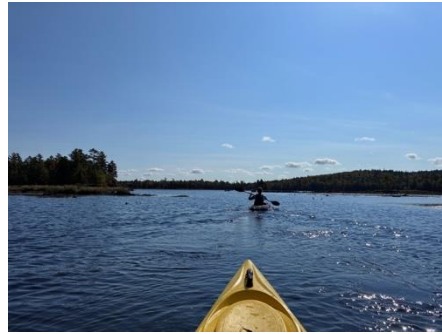
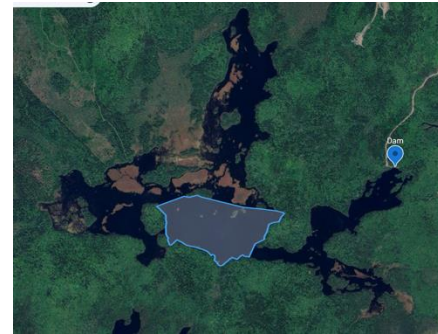
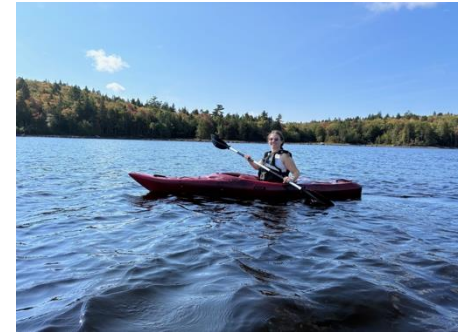
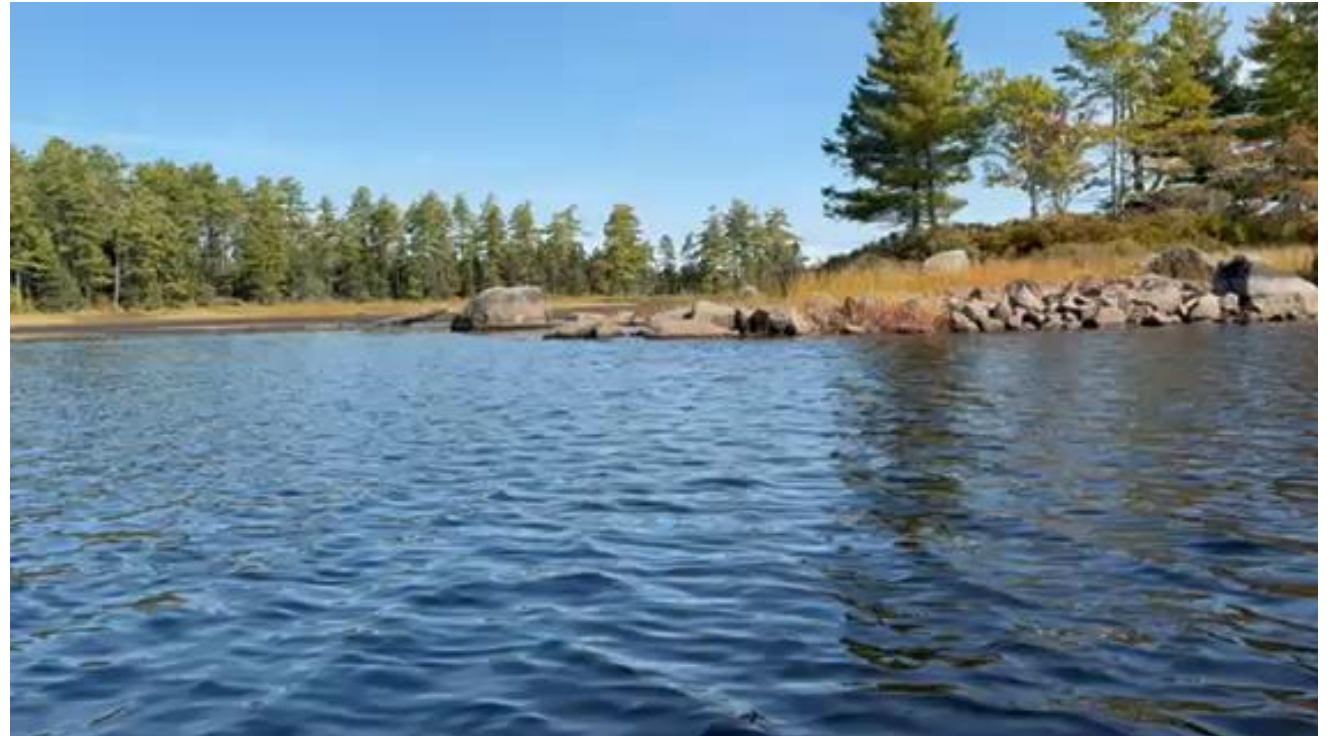
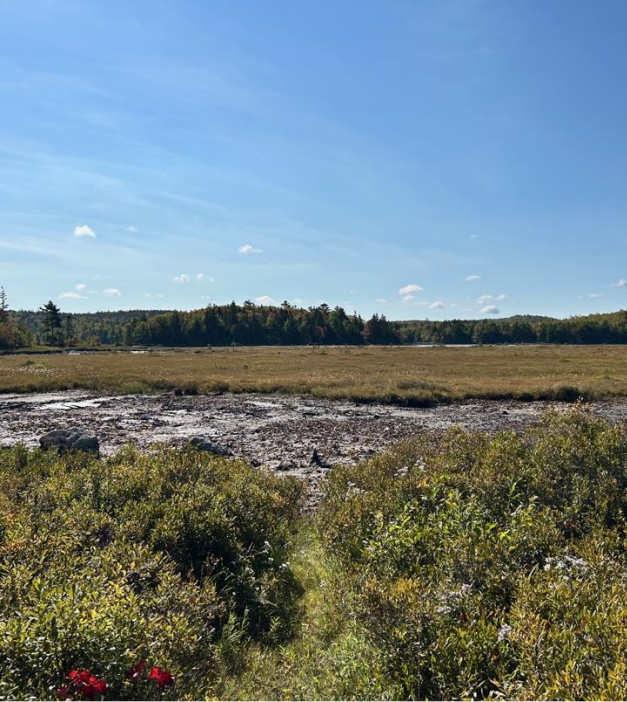
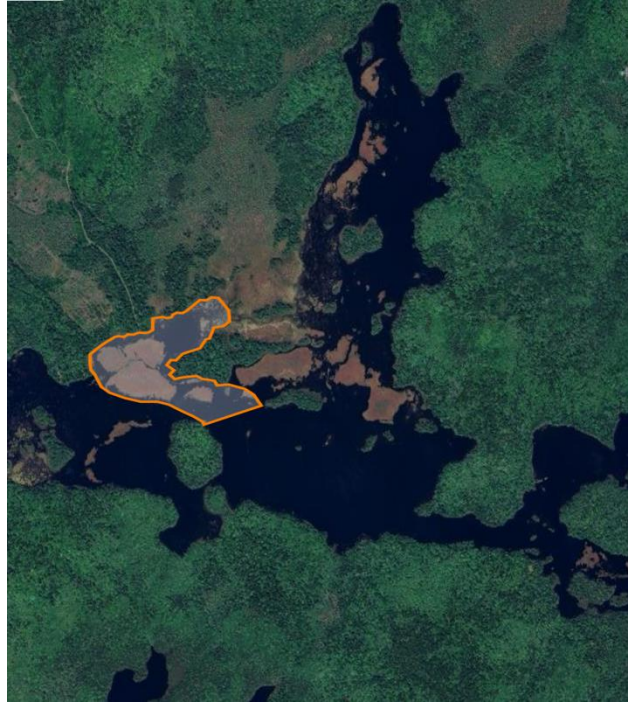
# Main Lake Area

- Largest area of lake Approx 300,000m<sup>2</sup>
- Largest volume of water however much is not accessible due to the change in elevation in the Dam area
- Depths measured were 112-122 inches

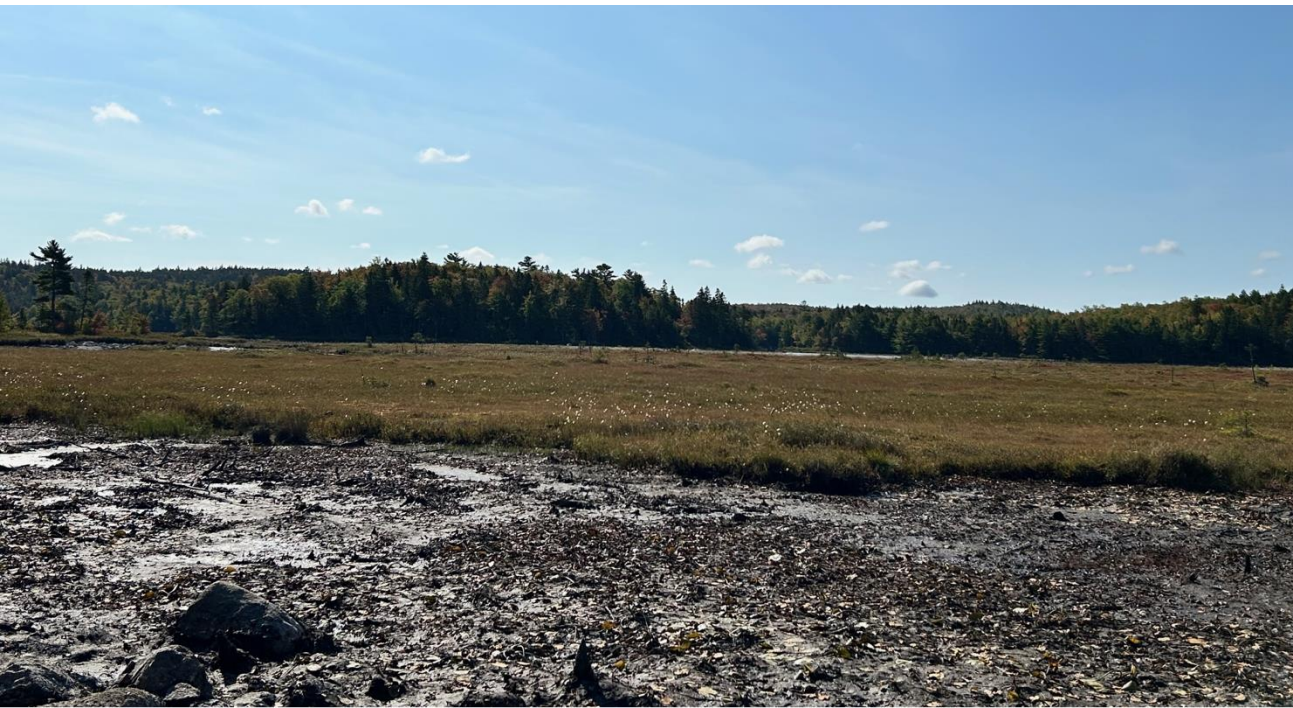
# Floating Bog

- Most of this area was dried or had limited access due to low water levels
- Typically, lower levels are found in this bog area, so considering the current drought conditions this was somewhat expected but startling to see

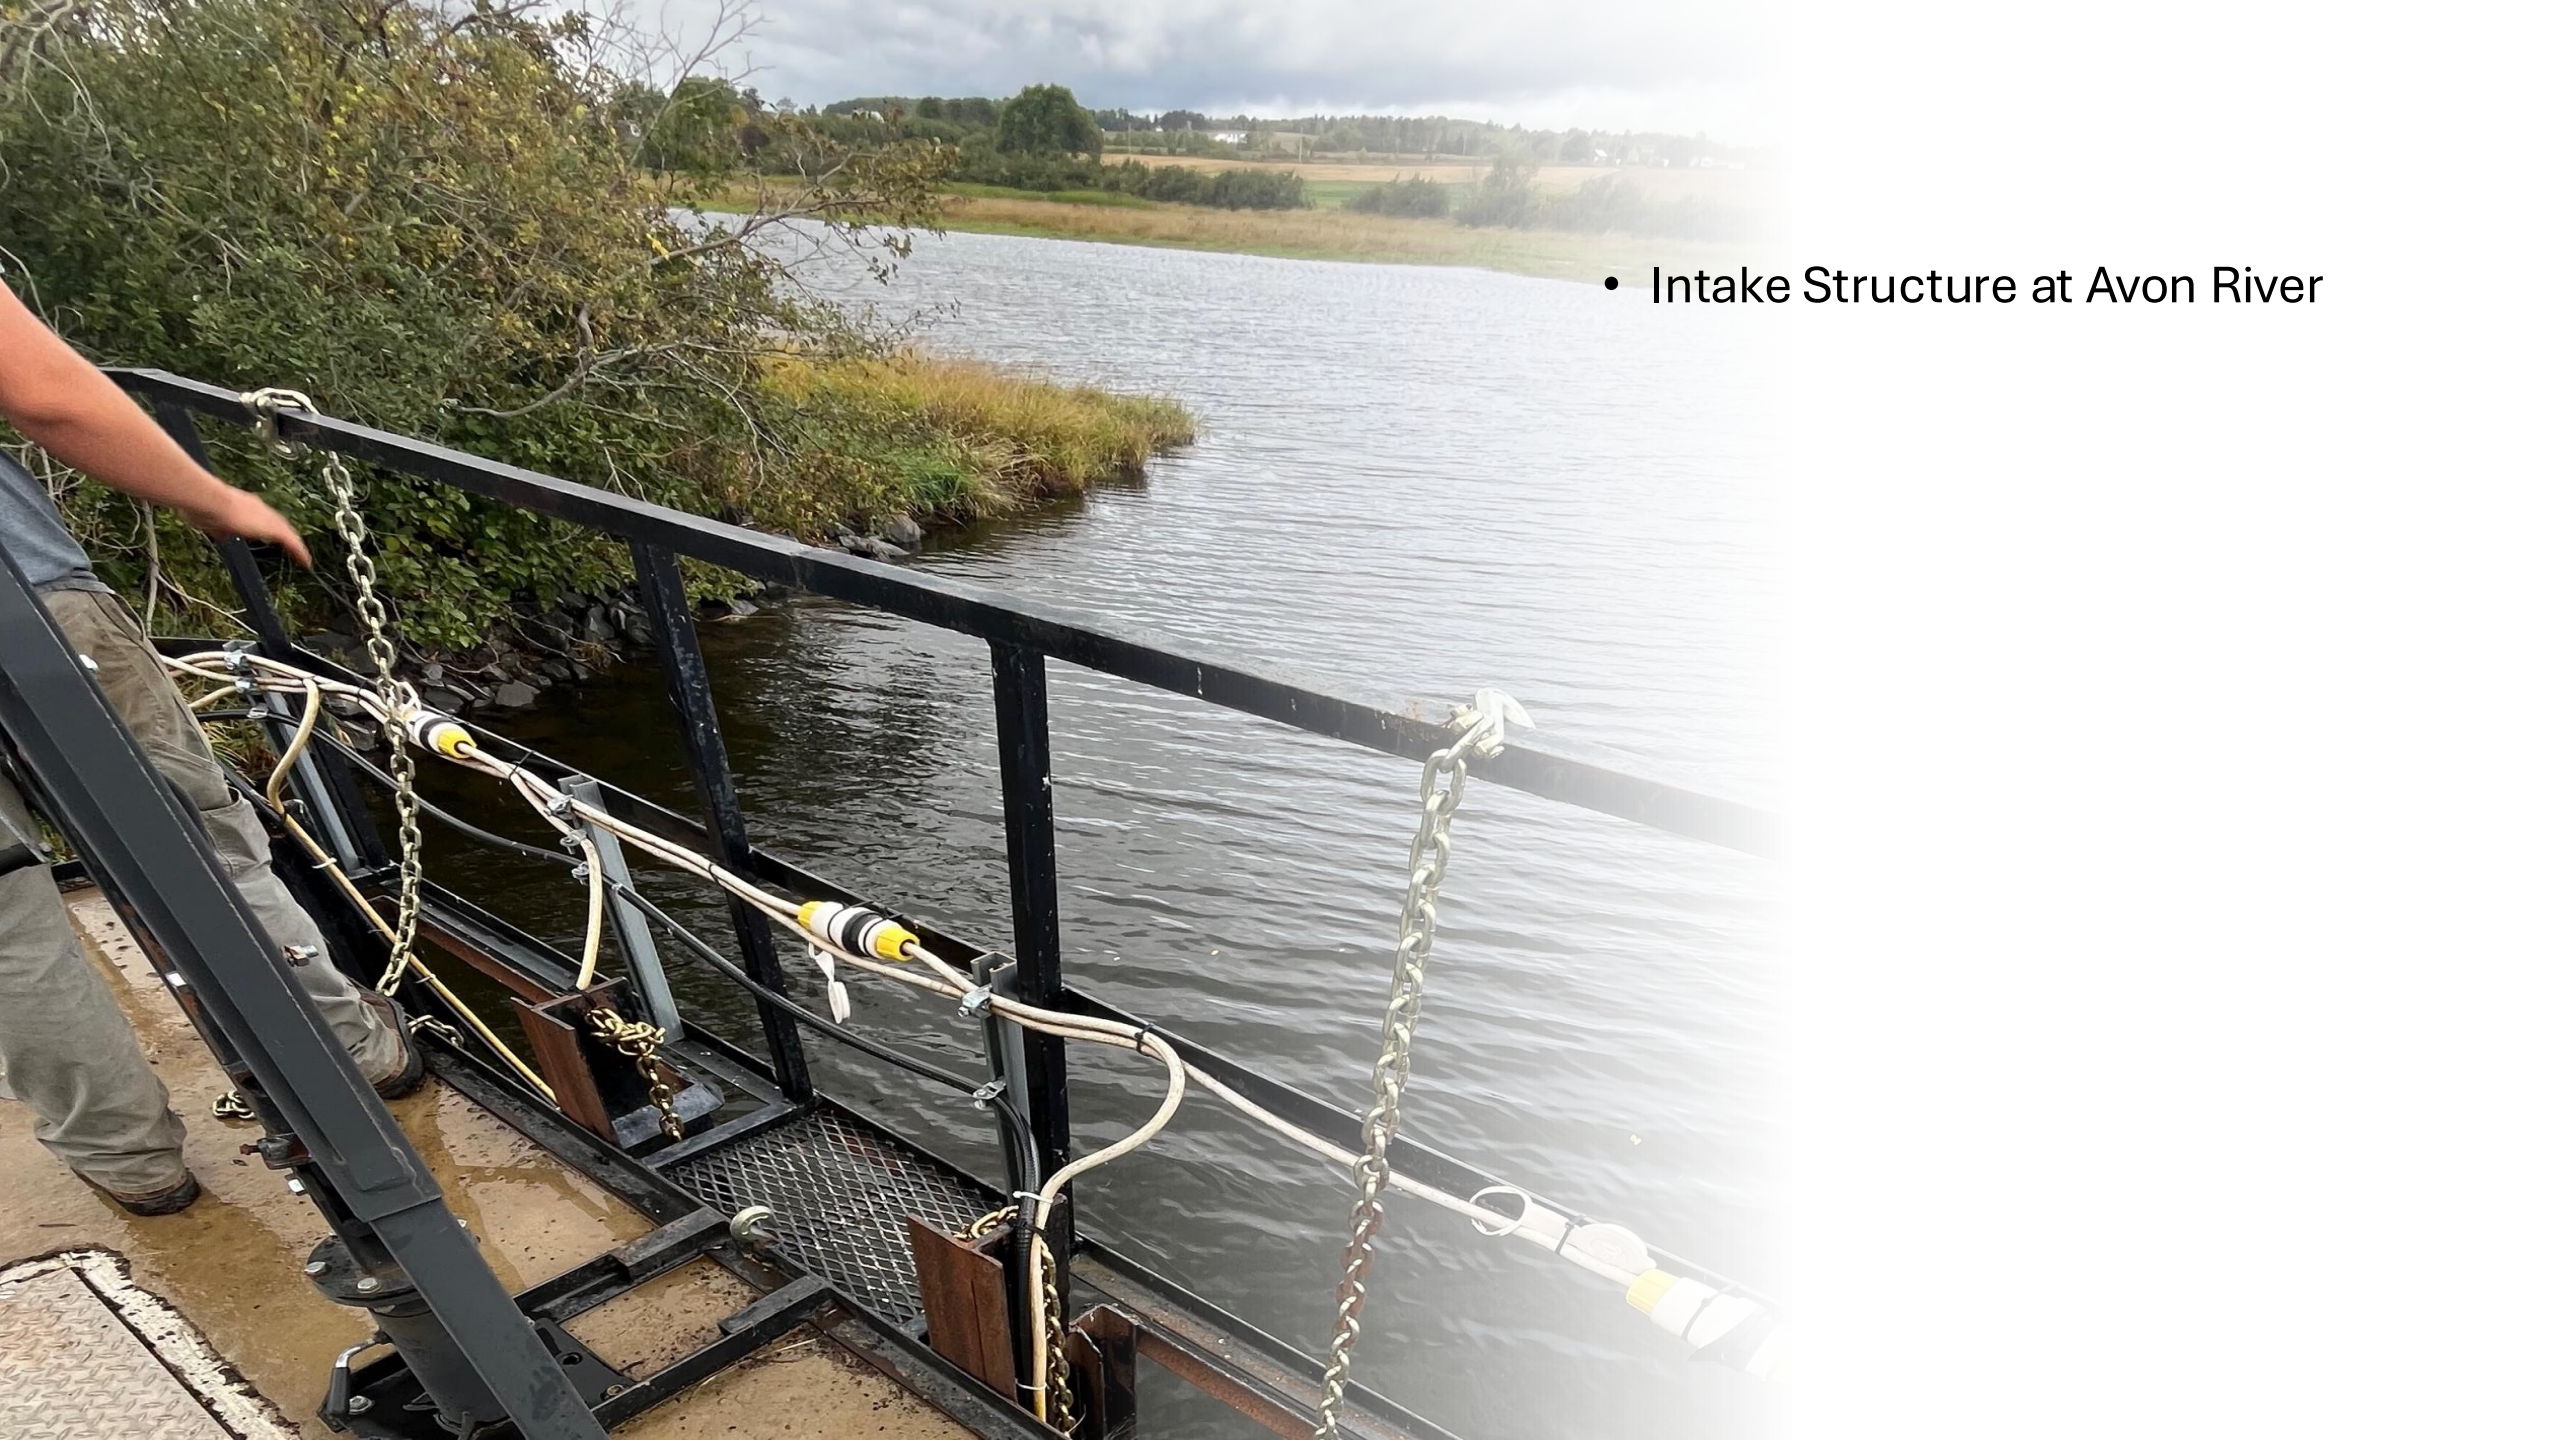
- Intake Structure at Avon River

- Fish Screening
