**Assessment of Flooding Hazard  
along the Highway 101 corridor near Windsor, NS using LIDAR**

Final Report submitted to the  
Nova Scotia Department of Transportation and Infrastructure Renewal (NSTIR)

Prepared by  
Dr. Danika van Proosdij  
Department of Geography

October 22, 2009

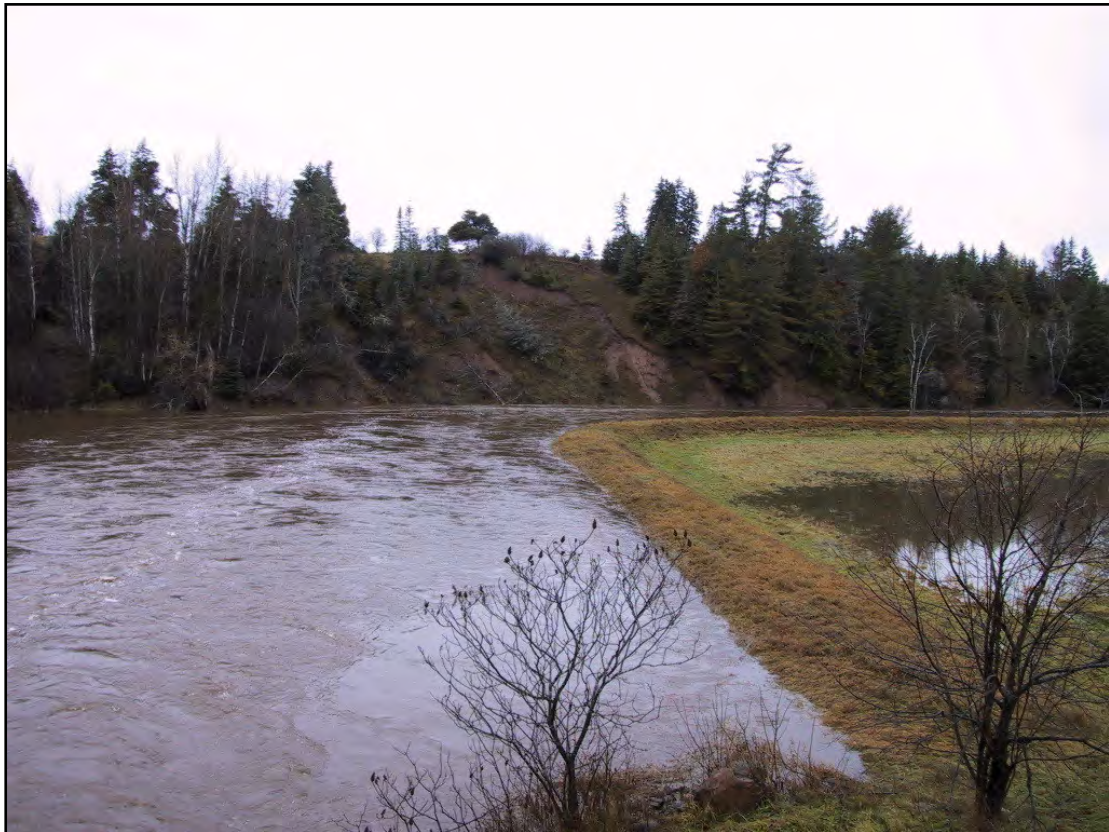
*Figure 1: Bankfull conditions along the St. Croix river near Wentworth Rd.*

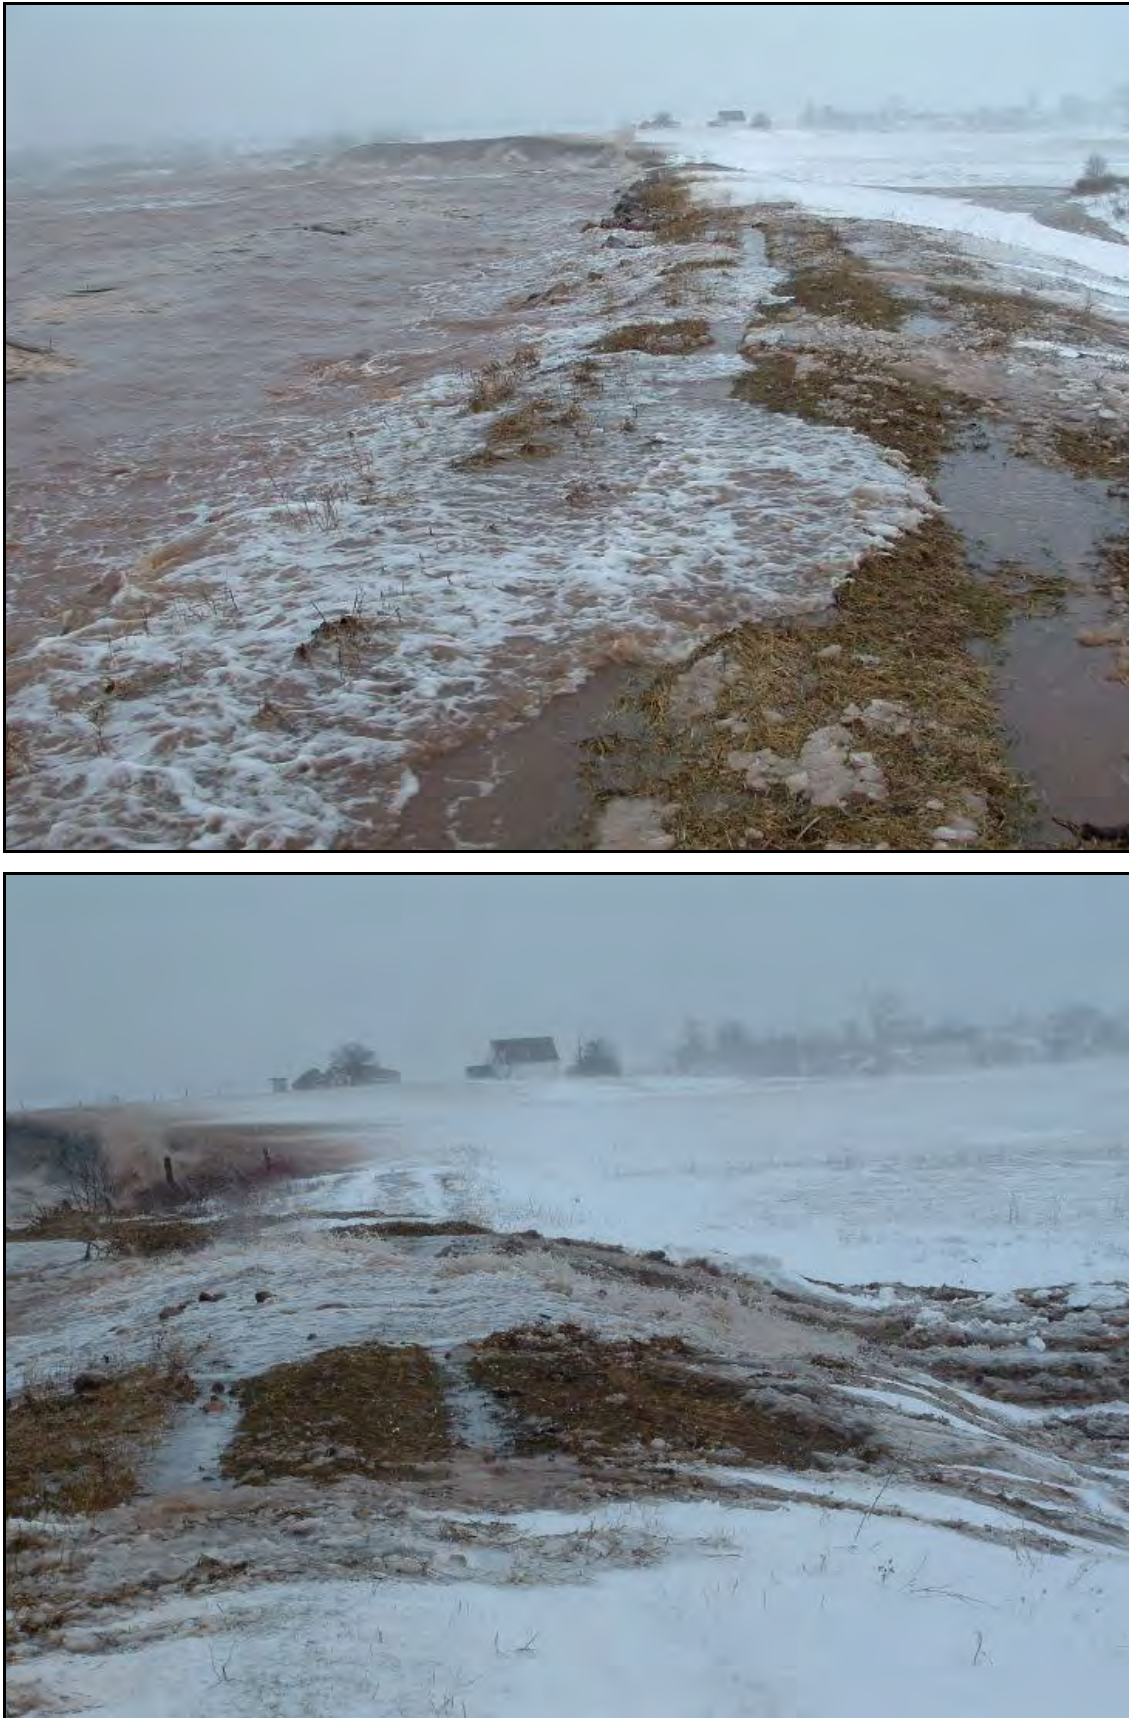
Figure 3: Storm impacts on Feb 1, 2006 at the Avonport Dyke. a) storm waves battering marsh; b) storm surge reached upper limits of dyke and dyke overtopped. Photo by T. Hamilton, 2006.

To date, the highest tides recorded at the causeway tide gate were 8.87 m (29.1 ft) (date unknown) (pers com. K. Carroll, 2007) and 8.6 m CGVD28 (28.2 ft) on January 10, 1997. These tide levels reflect the Saros cycle or the 4.5 yr cycle mentioned previously. Examining the digital record between April 2002 and September, 2006, a total of 121 tides exceeded the HHWLT elevation (7.57 m CGVD28). Eleven of these dates were greater than 8.0 m (Table 2) with the highest recorded tide on February 1, 2006 (8.2 m) which overtopped dykes in many areas (Figure 3).

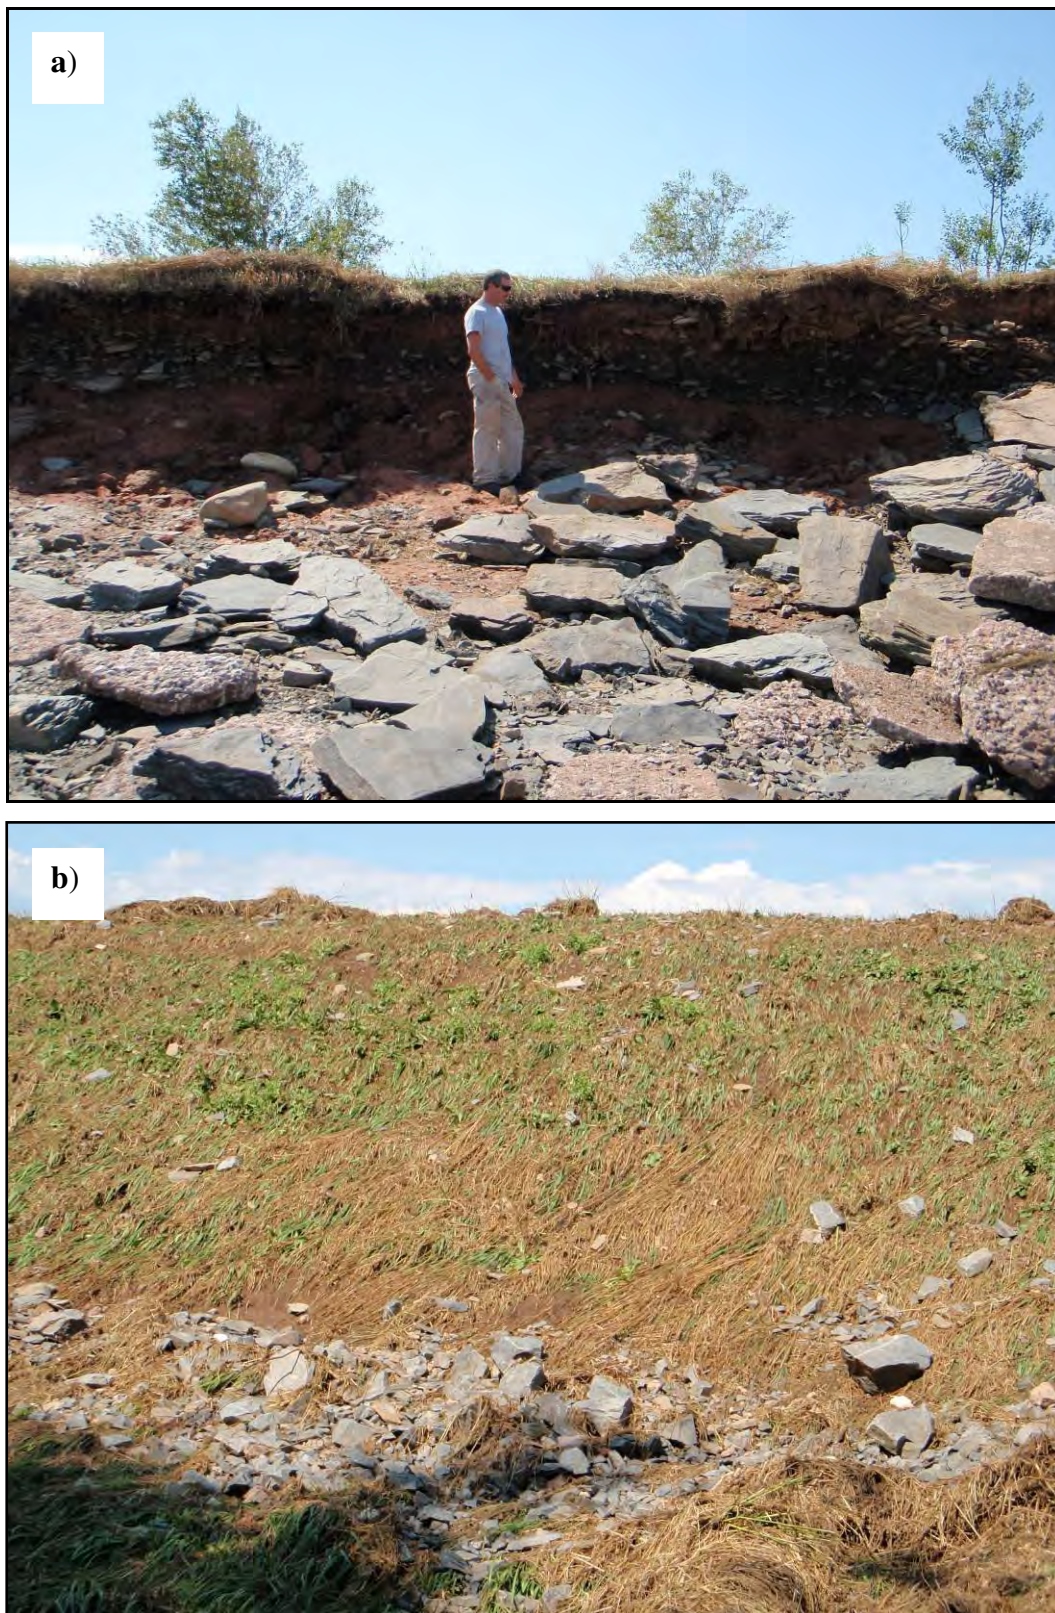
*Figure 4: Impacts of Hurricane Bill on dyke at Noel in August 2009. a) erosion and undercutting of earthen dyke structure and removal of shoreline armouring, b) armouring rocks transported to the landward side of the dyke by wave action and overtopping. Photo by K. Carroll, 2009.*
