**From:** Lachlan Riehl  
**To:** [Abraham Zebian](#); [Paul Morton](#)  
**Cc:** [PublicOnlyCouncilEmail](#)  
**Subject:** Halfway River - Information Re Flooding and Erosion Risks  
**Date:** November 19, 2024 9:38:48 AM  
**Attachments:** [2021-2022 Halfway River Habitat Assessment Report February 2022.pdf](#)  
[Halfway River Habaitat Assessment Report November 2018.pdf](#)

# Halfway River Tidal Wetland Habitat Assessment 2021

*Prepared by:*  
CBWES Inc.

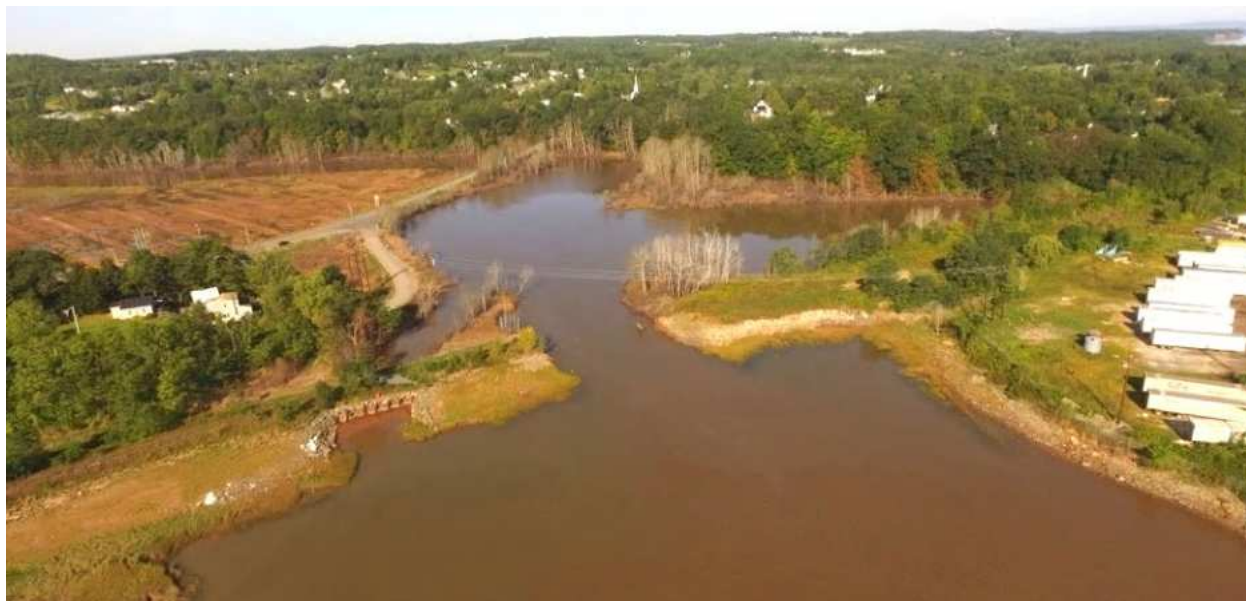
large wooden aboiteau structure within the base of the causeway and a smaller secondary multi-barreled metal aboiteau structure set high in the causeway to serve as relief valve during high water events. Lack of adequate maintenance of the causeway and aboiteau structure in recent decades contributed to its deterioration and the re-introduction of limited tidal flow to the river. Full tidal flow returned to the river in November 2017 with the complete failure of the causeway and aboiteau (FIGURE 3, FIGURE 4).

*Figure 4: Aerial photograph of mouth of the Halfway River and breach site. Photograph was taken at high (neap) tide on September 5, 2018. The secondary, overflow, aboiteau is to the left of the main opening. Drone imagery by CBWES 2020.*

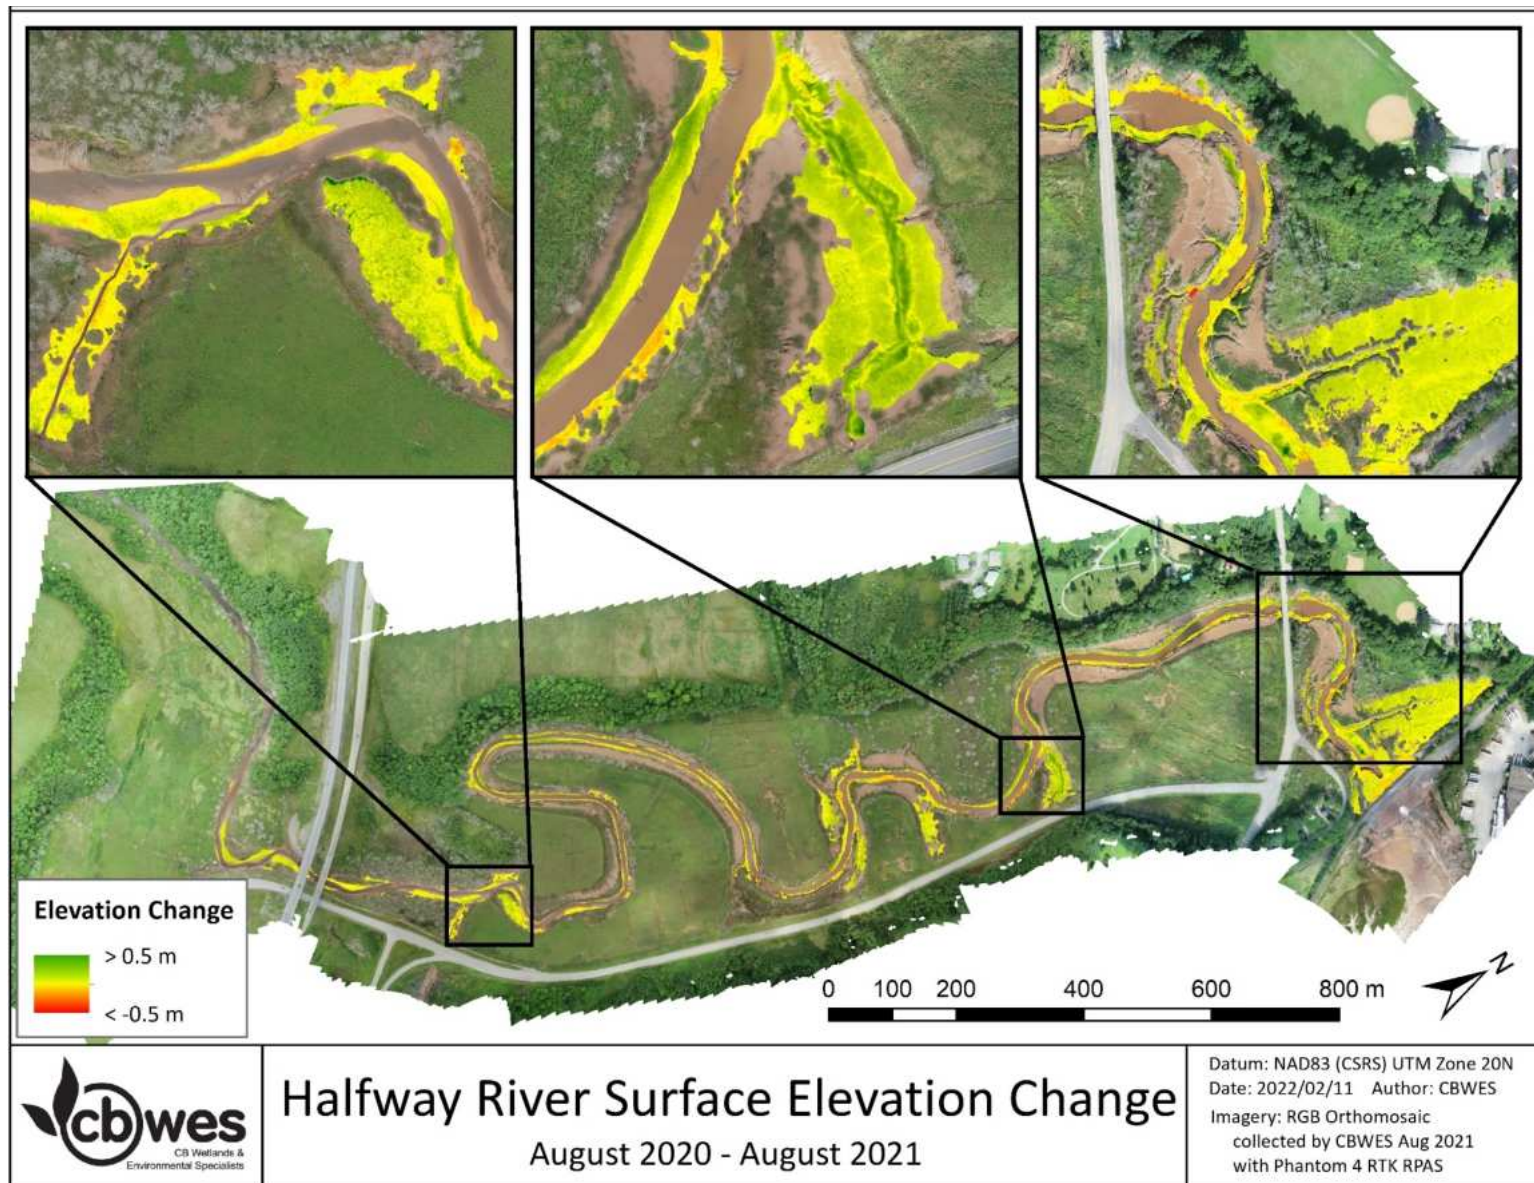
Elevations on the former high marsh (floodplain) have decreased from the pre-restoration condition but changed only nominally from 2019 to 2021. This may be due to root collapse of the former agricultural surface, though Lidar errors due to dense vegetation may also play a role. Elevations in the low marsh terrace have increased from the pre-restoration period, with seasonal increases observed in the fall of 2020 reflecting sedimentation patterns in the Bay of Fundy (May to November); however, seasonal analysis was not able to be completed in 2021 due to high water levels during the fall flight. The main Halfway River channel has shown no change in morphology. The armour stone associated with the new causeway-culvert structure has resulted in measurable scour immediately upstream of the structure.

Figure 17: Changes in elevation at HWR between August 2020 and August 2021.

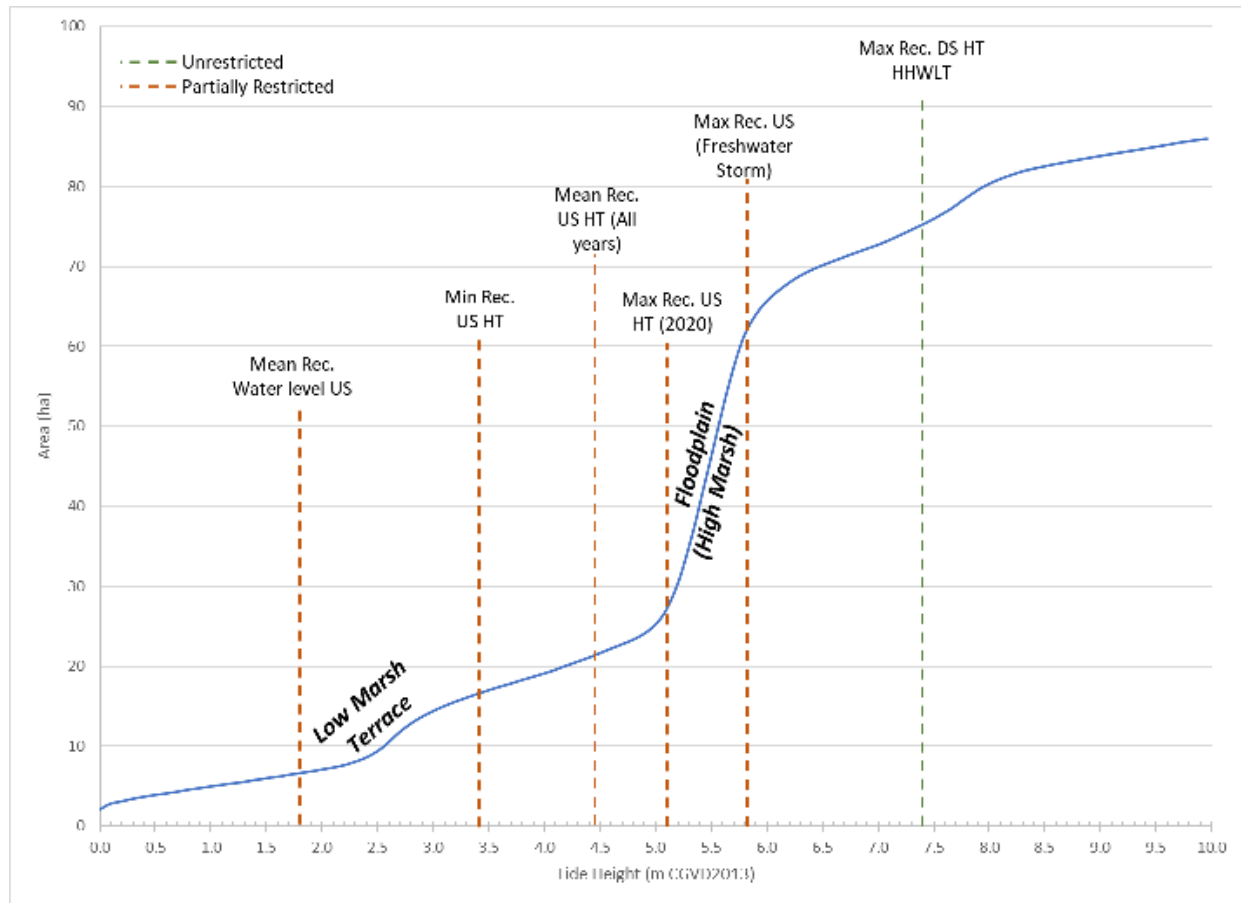
In the hypsometric curve (FIGURE 28), the high salt marsh platform (floodplain) and low salt marsh terrace are evident as a steep increase in flooding, with all high tide levels flooding the low marsh terrace but the high marsh flooding only on unrestricted tides or under storm conditions (predominantly freshwater flow) (as shown in FIGURE 29). Because the restricted tidal regime does not flood the high marsh platform except during storm events, the curve does not closely resemble that of a natural salt marsh.

Figure 28: 2021 hypsometric curve for Halfway River generated from the 2019 LiDAR with critical tides heights noted. US = upstream, DS = downstream, HT = high tide

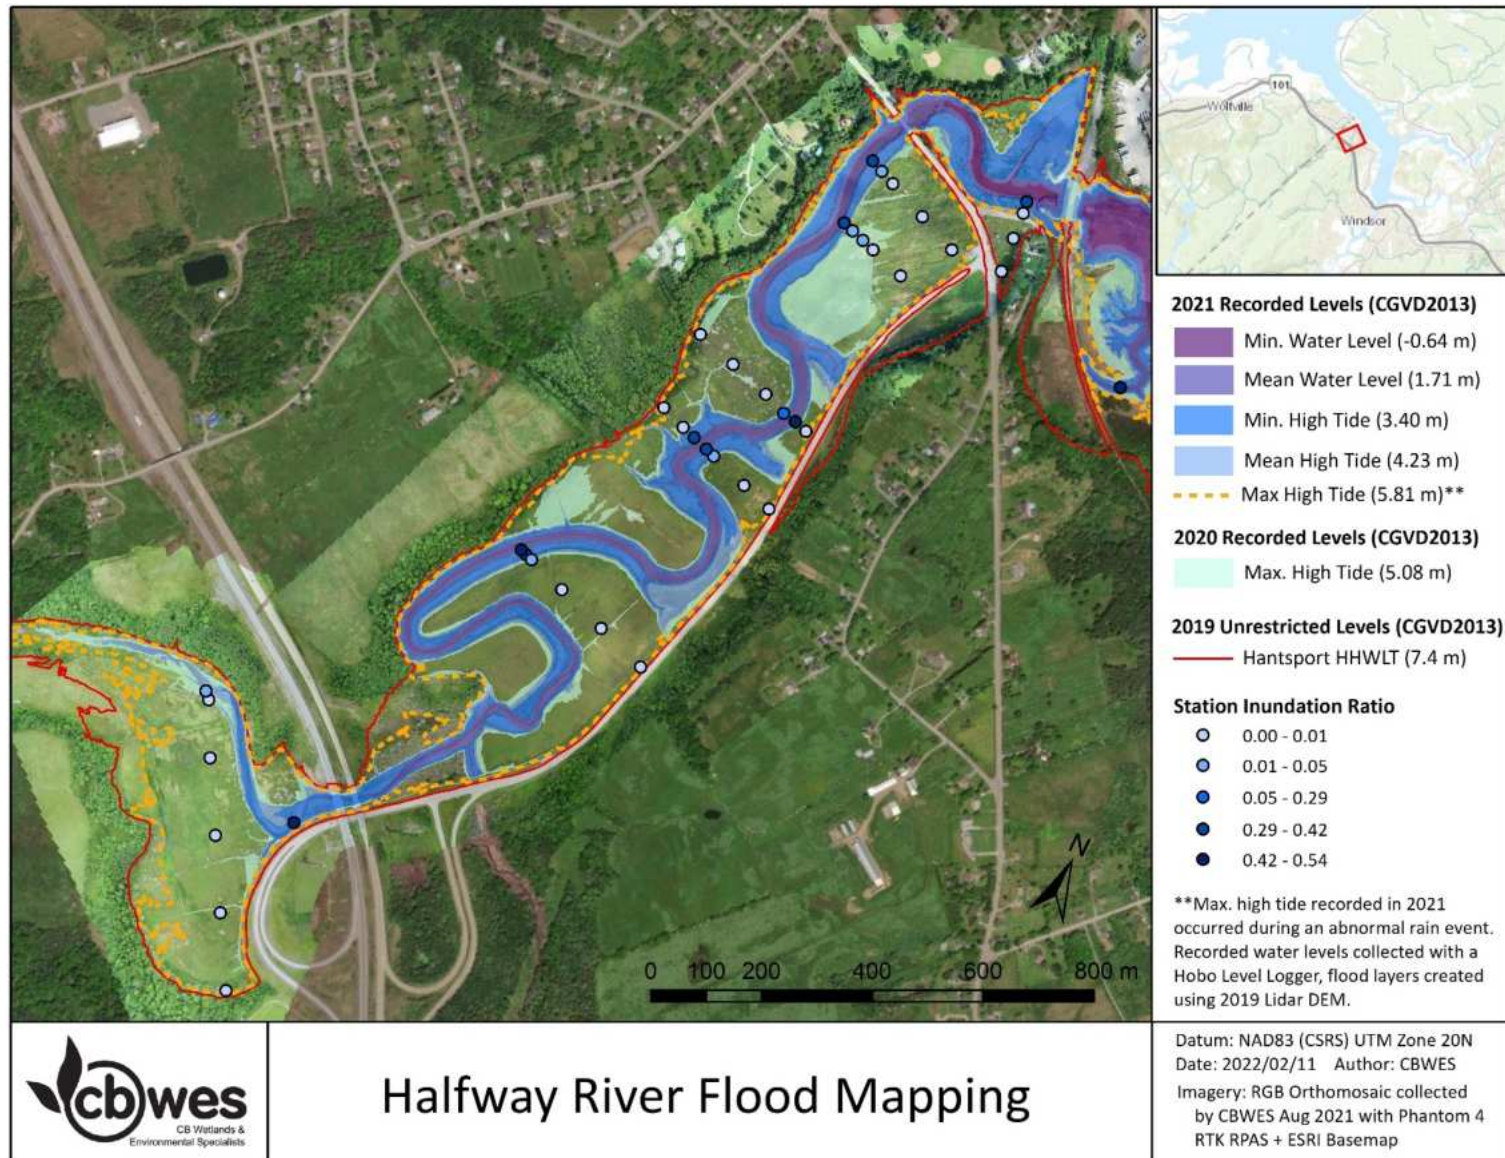
The flood map and hydroperiod statistics (Inundation Ratio (IR), Inundation Frequency (IF), and Mean Inundation Time (MIT)) are shown in FIGURE 29 and TABLE 6. As noted above, the Nov 23 rainstorm led to significant flooding throughout the site (water level 1.4 m below downstream HHWLT and flooded 80% of site area) and resulted in slightly higher flood metrics in 2021 than 2020. Flood metrics showed little change from 2020 and 2019 ungated tide signals. As described in previous years, only 26 of 75 ha are flooded by normal high tides. Inundation statistics show that when compared to unrestricted conditions, flooding is more frequent and longer in duration below ~ 3 m CGVD2013 and shorter and less frequent above that elevation. The delay in drainage caused by the culvert results in water being held in the site and increased inundation at low elevations, while flooding is decreased or eliminated at higher elevations.

Figure 29: HWR flood map showing extent of tidal flooding based on recorded tide data during unrestricted tidal flow.

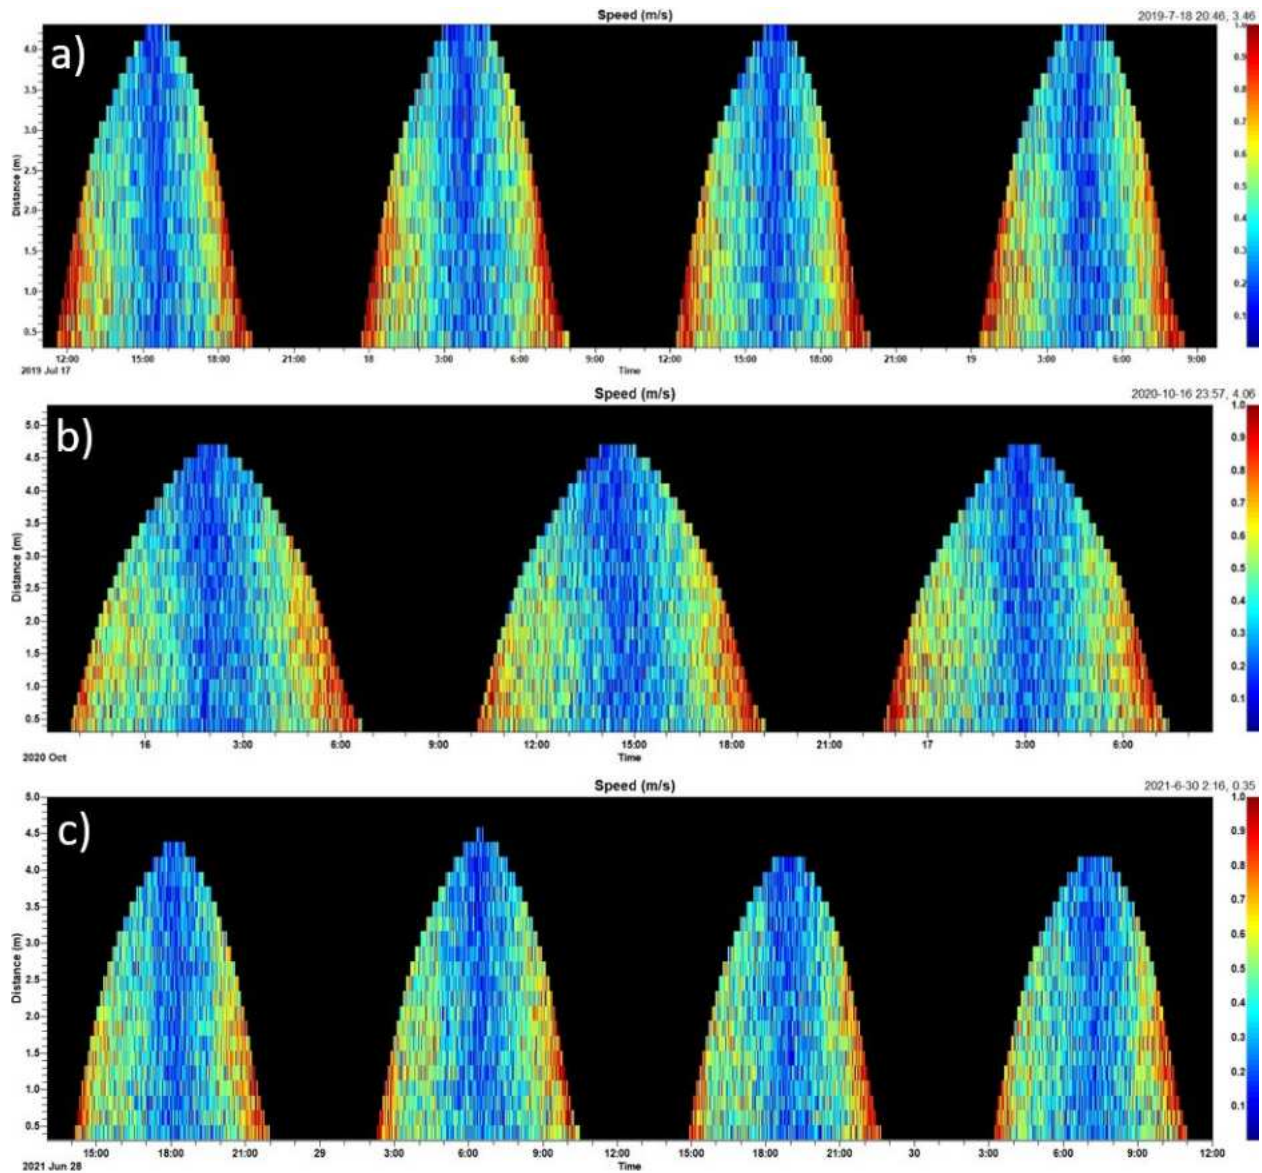
Velocity patterns from the ADCP show fast flow of water on the initial flood tide and on the end of the ebb tide (FIGURE 33). These figures show a time series of speed above the ADCP, which is in the main channel, over several tidal cycles. At these extremities of the inundation period at this site, water speeds are around  $1.0 \text{ m}\cdot\text{s}^{-1}$ . As the site fills with water velocities decrease, slowing down consistently to a minimum of about  $0.25 \text{ m}\cdot\text{s}^{-1}$ . Values for 2019, 2020, and 2021 were quite similar (FIGURE 33). The first sampling period, 2019, had speeds consistently at  $1.0 \text{ m}\cdot\text{s}^{-1}$  a little longer on both the very first part of the tide and the very last part of the tide (FIGURE 33a), though differences between years were quite small.

Figure 33: ADCP speeds for 4 tides during July 17-19, 2019; three tides during October 15-17, 2020; and 4 tides during June 28-30, 2021. Scale is  $0 - 1 \text{ m}\cdot\text{s}^{-1}$  with higher velocities in red.

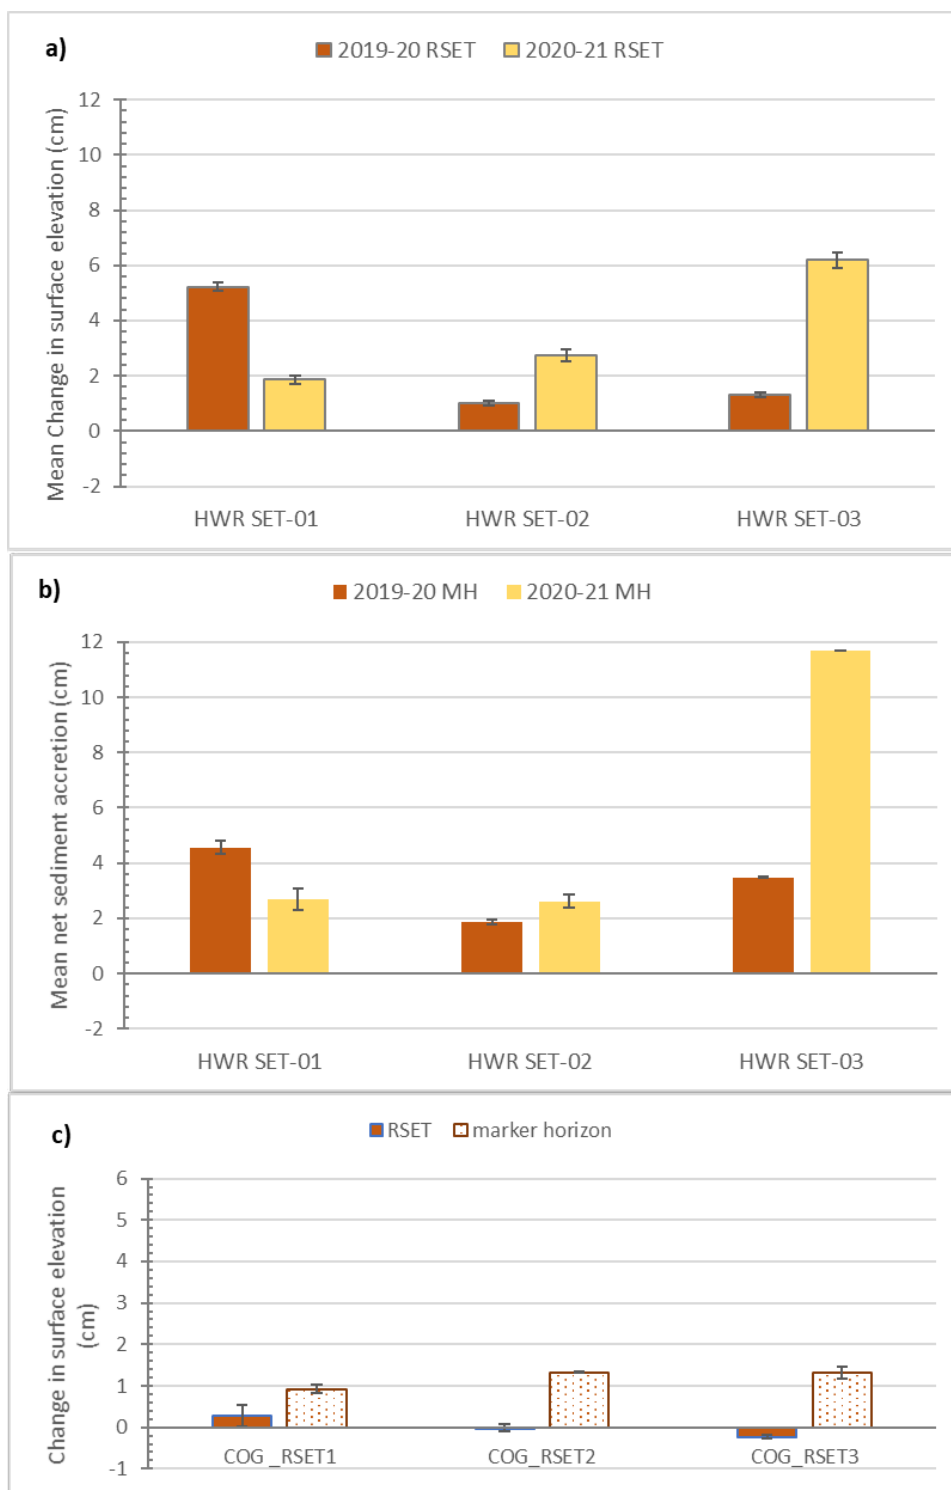
In 2020-21, however, the patterns of highest and lowest changes in surface elevation were reversed. HWR SET-01 on the foreshore marsh recorded only 1.86 cm with mean accretion of 2.69 cm (FIGURE 43, TABLE 8) resulting in net deficit in subsurface processes (-0.83 cm) (TABLE 9). The change in surface elevation at HWR SET-02 was almost 2.5 times greater than in the previous year (TABLE 8) with higher sediment accretion (2.61 cm) as well and overall net positive below ground contribution (TABLE 9). Significantly higher sediment accretion was recorded at the station furthest upriver. HWR SET-03 recorded 11.7 cm of deposition and was highly bioturbated and only one viable core was used for the analysis (TABLE 9, TABLE 10). However, this only contributed to a 6.19 cm change in surface elevation (TABLE 9, FIGURE 43) reflecting a loss of 5.5 cm in root production or compaction (TABLE 10).

The annual change in surface elevation recorded by the RSETs at HWR is more than double than values previously recorded at the Cogmagun reference site (TABLE 10, FIGURE 43). The reference site also recorded negative decay of below ground material which is typical of formally impounded sites as the site transitions from freshwater to brackish or salt tolerant species.

Figure 43: Comparison of RSET and MH measurements at a) HWR and b) reference site COG.

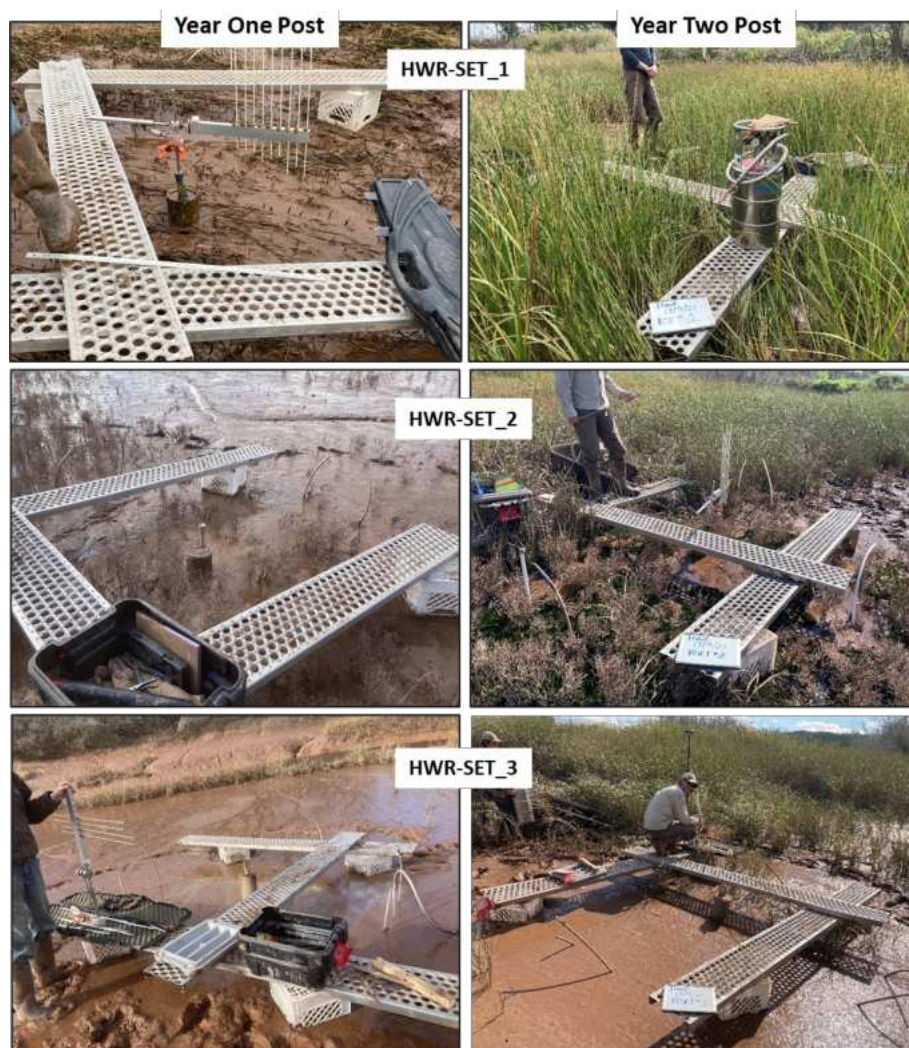
Sedimentation is directly influenced by the number of tides that flood each station (inundation frequency) and how long sediment laden tidal waters are on site (inundation time). Based on the 2021 record, HWR SET-03 is flooded on all tides with a mean inundation time of 283 min and 1.41 m of water at max tide compared to HWR SET-02 which is flooded by 86.7% of the tides for 151 min by a maximum of 0.25 m of water (TABLE 6). This likely explains the higher sedimentation at HWR SET-03. All sites exhibited visible growth of halophytic vegetation (FIGURE 44).

Figure 44: One year and two year post photos at HWR RSET sites.

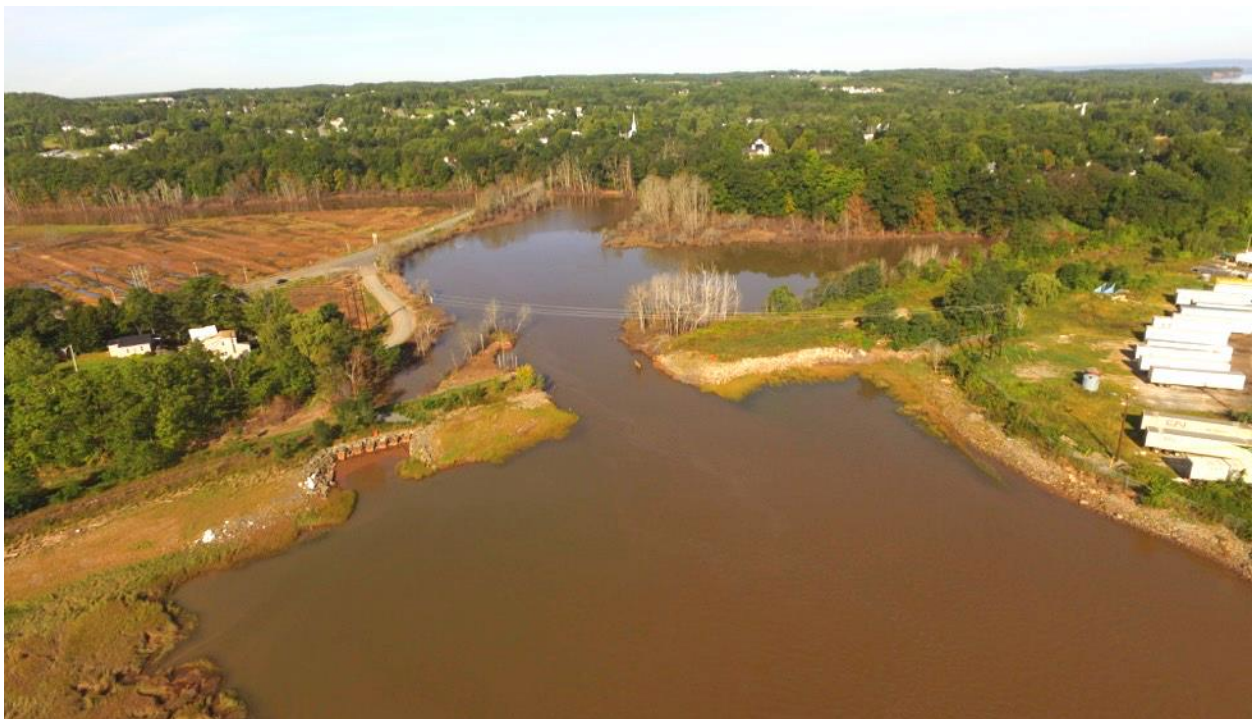
**Figure 4** Aerial photograph of mouth of the Halfway River and breach site. Photograph was taken at high (neap) tide on 5 September 2018.

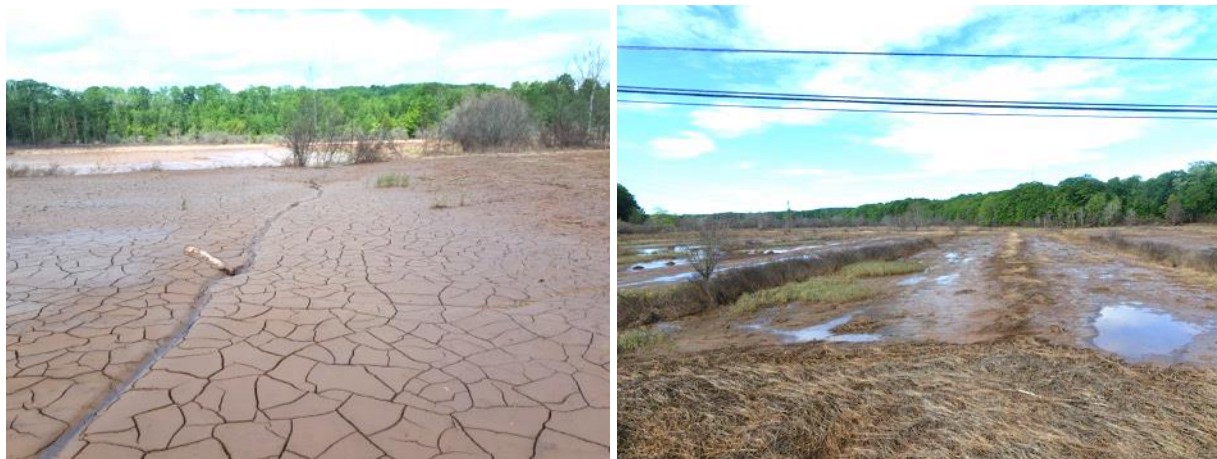
**Figure 8** Heavy sedimentation in one of the main dales (left) and exposed crowns with dead grass visible (right). Photographs by CBWES Inc., 26 June 2018.

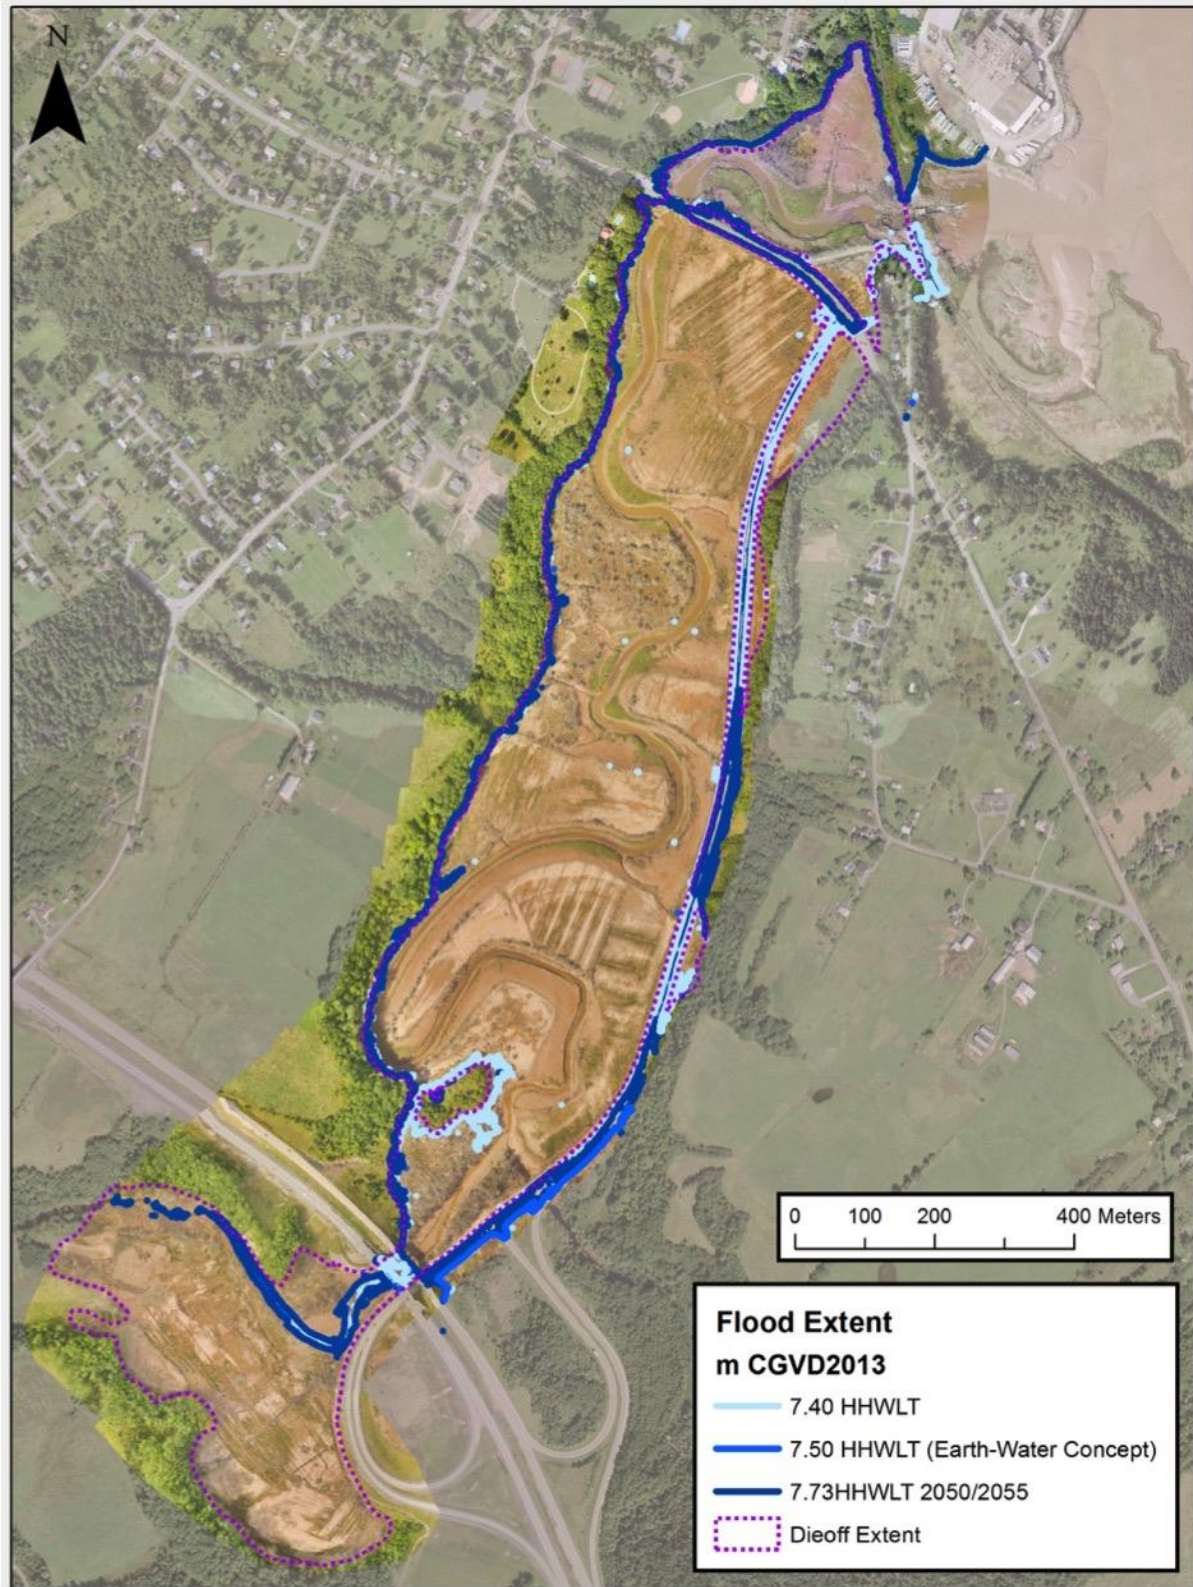
Figure 11 Flood extent generated from 2018 DSM line up well with the die-off extent observed in the orthomosaic, except south of the highway where no GCPs were deployed and elevations were invalid.

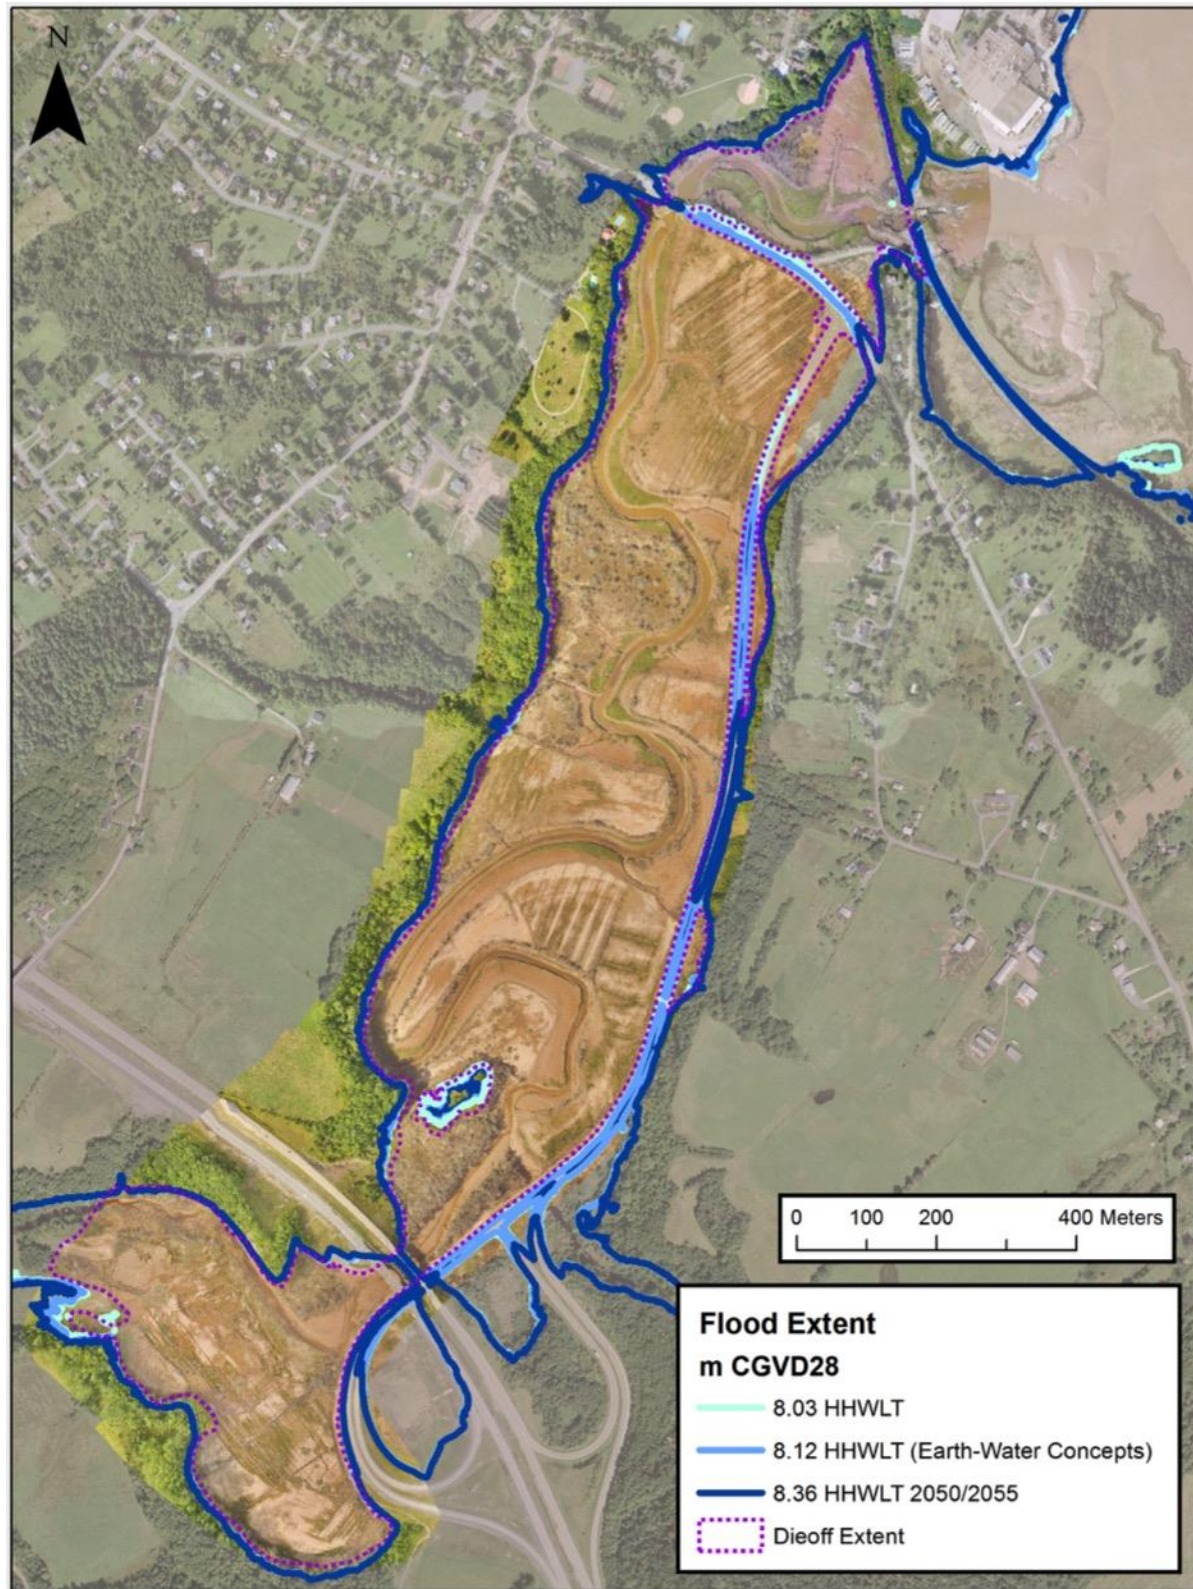
Figure 12 Flood extent generated from 2007 DEM (AGRG/SMU) slightly exceed die-off extent observed in the orthomosaic.

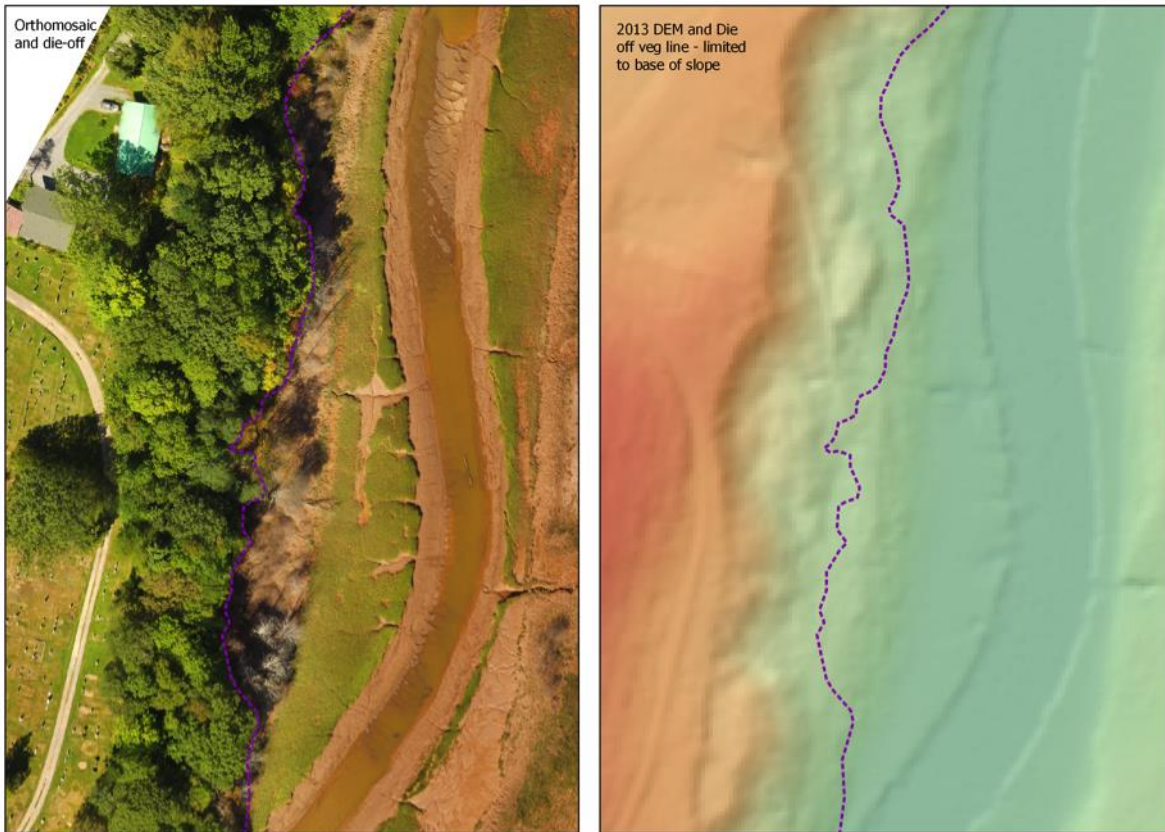
**Figure 15** Close up of die back over both orthomosaic and 2013 DEM surface.

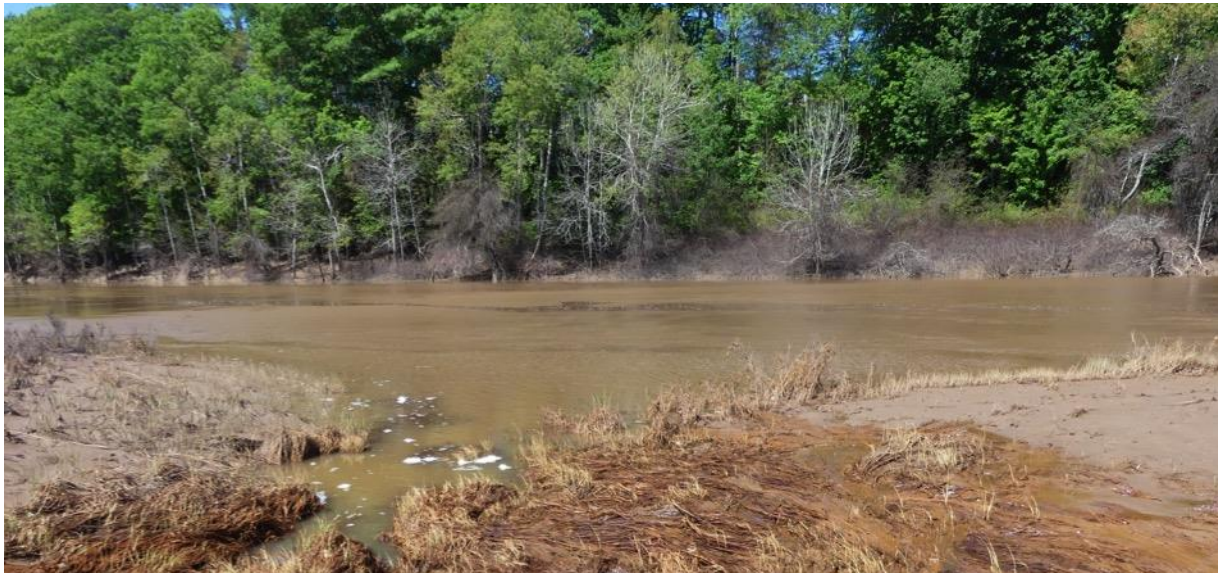
**Figure 16** Dead trees on the marsh platform below the River Bank Cemetery. Photograph by CBWES Inc. June 26, Rising tide.

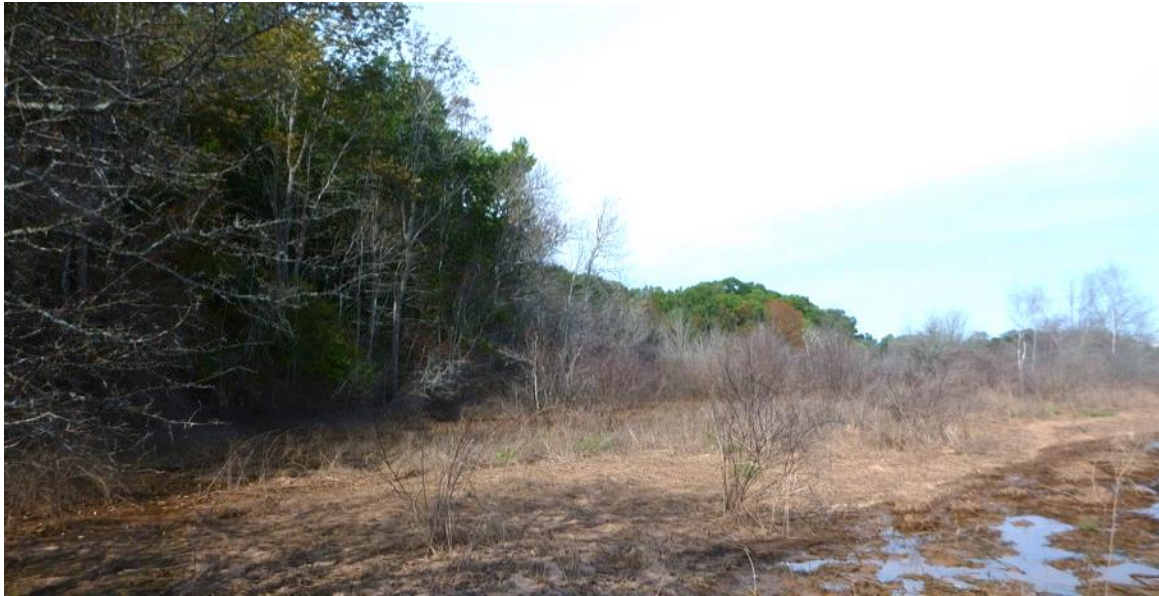
**Figure 17** Trees and shrubs dying on the platform upstream for the Riverbank Cemetery. Photograph by CBWES Inc. September 24, falling spring tide.

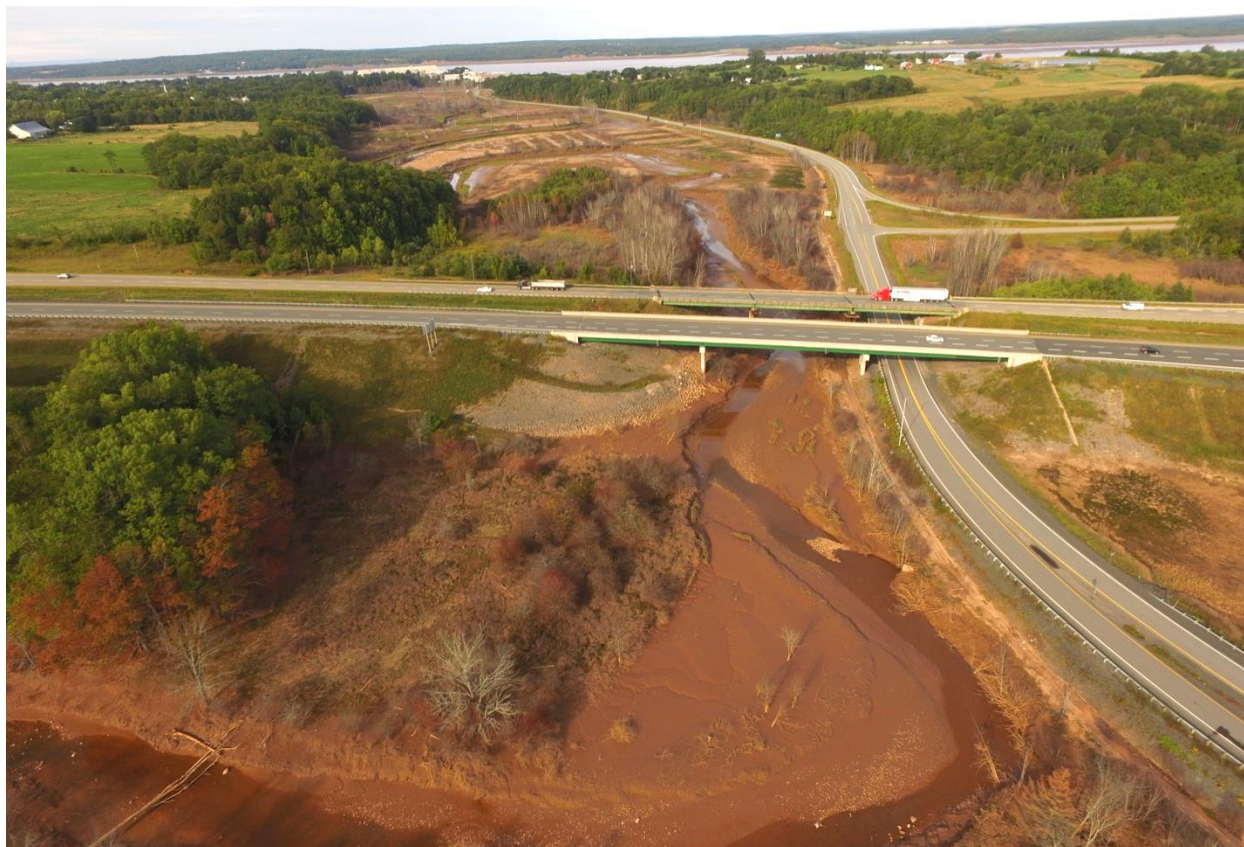
Regarding the transportation infrastructure that is within and bordering the river system, specifically sections of Highway 1 near the mouth of the river, the Highway 101 Exit 8 on/off ramps, and a low-lying section of Schurman Rd., are vulnerable to flooding during peak spring tides and storm surge events (Figure 20; Figure 21). However, it is our understanding that NSTIR is aware of these areas of vulnerability and are prepared to take the necessary actions to upgrade their infrastructure to alleviate the risk. Eddies and scour pools were observed both downstream and upstream side of the Highway 1 bridge which is indicative of restricted tidal flow (Figure 22, Figure 23). Monitoring of conditions and the bridge by NSTIR is ongoing.

Figure 20 Sediment deposition due to flooding on the low-lying section of Schurman Road (currently closed due to flooding).
